## Soyuz investigation findings backed by nominal Soyuz TMA-13 return

April 8, 2009 by Chris Bergin

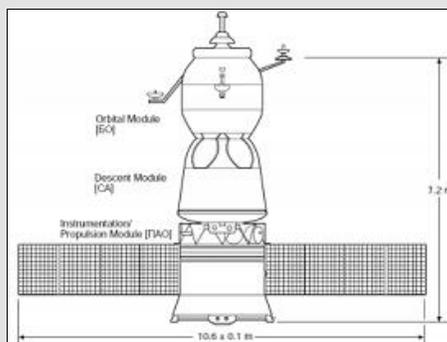
The nominal re-entry and landing follows an issue-free return for Soyuz TMA-12. However, Soyuz TMA-11 and TMA-10 both suffered from what is called a ballistic re-entry – a degraded mode for landing, which initiates a steep trajectory, resulting in a much shorter than planned re-entry, exposing the crew to up to 10G.

The Soyuz Vehicle consists of three modules: the Orbital Module, the Descent Module (DM), and the Instrumentation/Propulsion Module (IPM). All three modules nominally separate simultaneously, shortly after the deorbit burn is completed – at around 140 km altitude.

The two “off nominal” re-entries in 2007 and 2008 were the cause of separation failures on the modules, thus initiating the ballistic return for their three person crews.

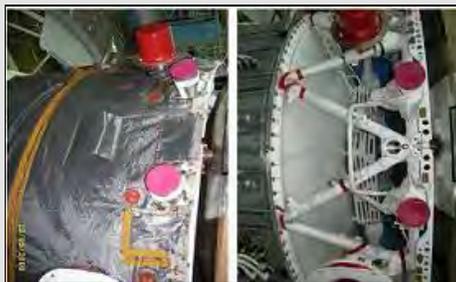
“Changes made to 17S (TMA 13) vehicle in response to Commission findings: Based on the Russian Commission findings, several changes were made to the 17S vehicle currently on-orbit,” added the document.

“Corrected the grounding issues at the Plane 1 pyro lock location. Physical separation of the pyro firing cables. Lockwiring the pyro connectors.

Replaced the pyro bolts with a more robust design that is less susceptible to the electromagnetic environment.

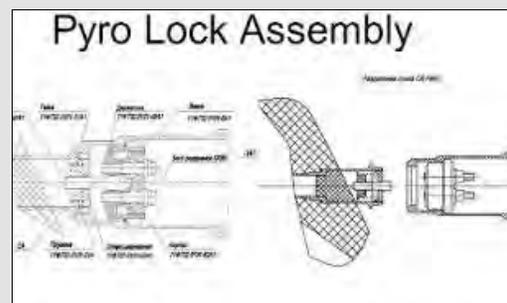
Also included in the presentation is one slide titled “Alternative Engineering Evaluations,” noting dissenting opinion on the Russian findings on the root cause of the pyro bolt issues, although it is conceded that the alternative explanation has a low probability.

“ISS environments team does not feel that plasma environment caused electrical potential issue, BUT, with improperly grounded system, failure of the type predicted is possible. Pyrotechnic experts

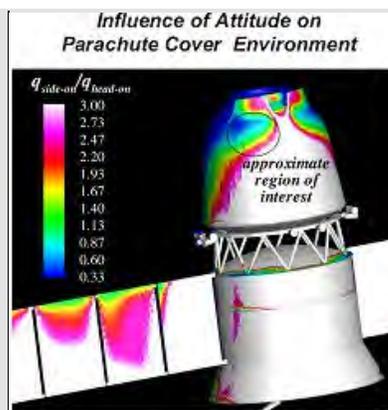
“17S vehicle has several modifications to address the identified most likely root cause: Replaced pyros (8X55 with 15X571) with a design less susceptible to EMI (similar to those used in the APAS).

“Improved bonding in Plane 1 pyro lock area with the used of Aluminized tape. Replaced explosive bolt power cables with new cables having enhanced shielding.

Routed the cables attached to the explosive bolts along two independent paths. Introduced lockwiring of pyro bolt electrical connections.

“The software patch is available and planned for use, analysis indicates that it will help ensure separation. Independent re-entry analysis indicates truss will likely fail due to thermal heating prior to hatch or parachute compartment failure, leading to successful re-entry.”
