SpaceX Falcon 9 failure investigation focuses on COPV struts

July 20, 2015 by Chris Bergin

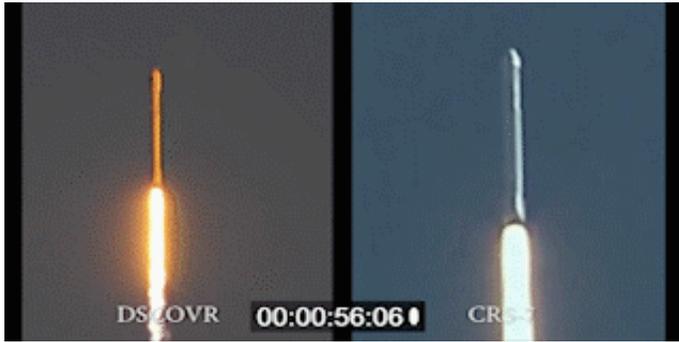
However, [an overpressure event in the Second Stage 139 seconds after liftoff](#) resulted in the loss of Dragon and the disintegration of the Falcon 9 launch vehicle.

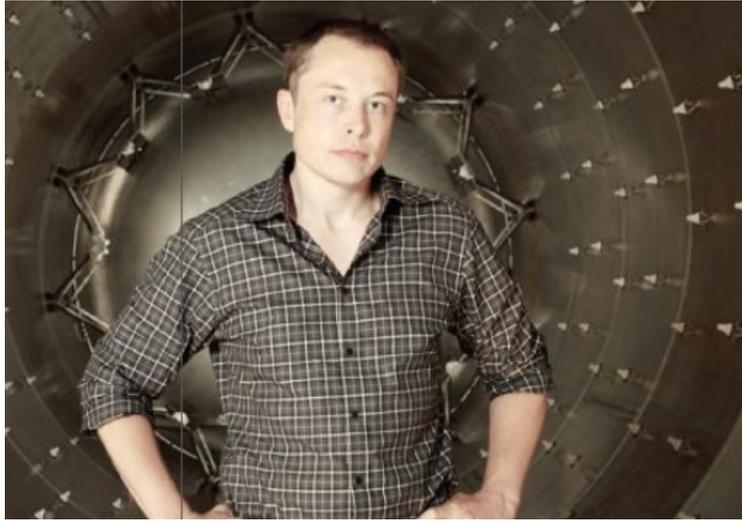
It was not immediately obvious the strut was the hardware that had failed, based on flight experience and ground testing, resulting in data on hundreds of struts – including those that had already flown without issue.

Also, the struts were designed to handle 10,000 lbs of force, per its certification. However, based on the period of when the Falcon 9 failed, it is estimated that the force would have been around 2,000 lbs.

SpaceX also examined the CRS-7 Falcon 9's processing flow, reviewing closeout photos that showed no obvious issues with the struts inside the tank during assembly.

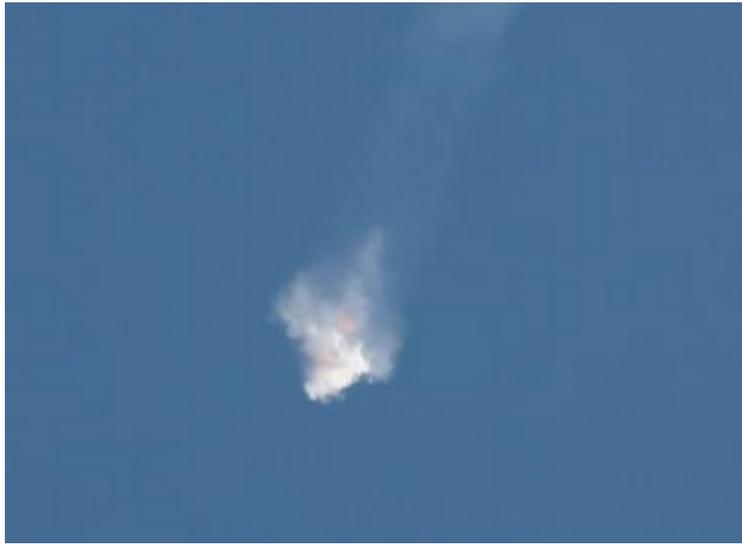
“The telemetry data also somewhat confusingly shows a drop in helium pressure – which you’d expect with a breach in the system – and then, somewhat strangely, a rise (of pressure) in the system, back to its starting pressure. This is obviously quite confusing.”

The theory revolves around a bottle breaking free, twisting around, resulting in its helium line “pinching” off the helium manifold, which subsequently restored pressure in the helium system. However, it would have still released enough helium into the tank to cause the Second Stage to fail.

“This is somewhat speculative, but that’s the best explanation we can think of right now,” added Mr. Musk. “A really odd failure mode.”
