Mishap at an Explosives R&D Laboratory

Mishap with an Energetic Material at an R&D Laboratory

At 10:45 pm on February 14, 2005, an explosion and fire occurred in the R&D laboratory building M-590 at the ATK Thiokol Promontory campus.

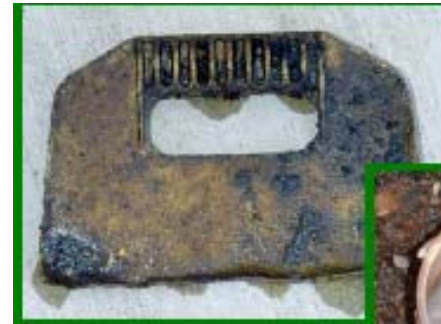
- The technicians were transferring what was thought to be TETNB from a large filter tray into 5-gallon buckets
 - Standard tools include plastic spatulas and ice cream buckets
- They encountered an unusual condition: the energetic material was caked hard in the bottom and on the sides of the filter tray
 - Caked material was an unexpected result of a process considered experimental
- The technicians attempted to solve the problem on their own by removing the caked energetic material with unauthorized tools (metal scoop and plastic shovel).
- **Most probable proximate cause:**
Impact from one of these tools resulted in ignition of a TNPG-rich crystal.
