That Sinking Feeling: Total Loss of Petrobras P-36 *

* A floating oil drilling platform designed and operated by **Petróleo Brasileiro S/A** (aka Petrobras)

Leadership ViTS Meeting
October 2008

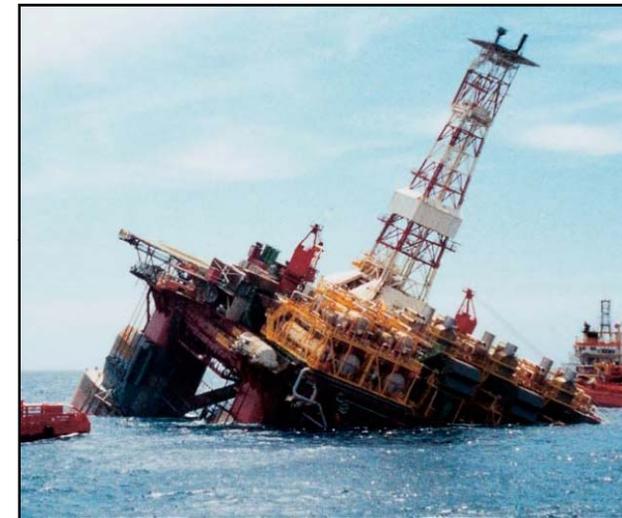
“THE PROJECT SUCCESSFULLY REJECTED ... PRESCRIPTIVE ENGINEERING, ONEROUS QUALITY REQUIREMENTS, AND OUTDATED CONCEPTS OF INSPECTION ...”

A PETROBRAS EXECUTIVE, PRIOR TO THE ACCIDENT, ON DELIVERING SUPERIOR FINANCIALS
