SYSTEM FAILURE CASE STUDIES

DECEMBER 2008 VOLUME 2 ISSUE 10

Under Pressure

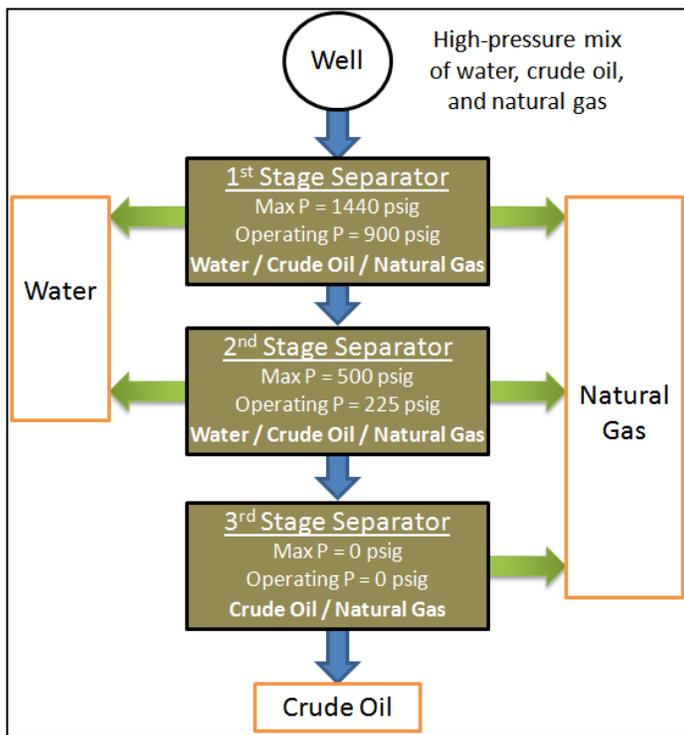
Figure 2 displays a schematic of a separation train like the one used in Pitkin, LA, where the constituents of the well fluids were to be separated over three stages. The first stage separator vessel was designed to handle the highest pressure coming directly from the well. The maximum safe operating pressure was 1440 psig, where psig is the differential between internal pressure and atmosphere. With some of the natural gas and water removed from the crude oil, the pipeline would pass a lower pressure mixture of fluids to the second stage separator vessel, which had a maximum safe operating pressure of 500 psig. More of the natural gas and all of the water was to be removed before the fluids reached the third stage separator, which could only operate safely at atmospheric pressure (0 psig). Typical operating pressures were well below maximum allowable pressures for the first and second stages at 900 and 225 psig, respectively. The

third stage, however, was designed to operate exactly at atmospheric pressure.

Figure 2: A separation train uses three separator vessels to progressively sequester components for storage and sales.
