Wire to Wire: *Swissair 111 Crash*

Leadership ViTS Meeting

February 2010

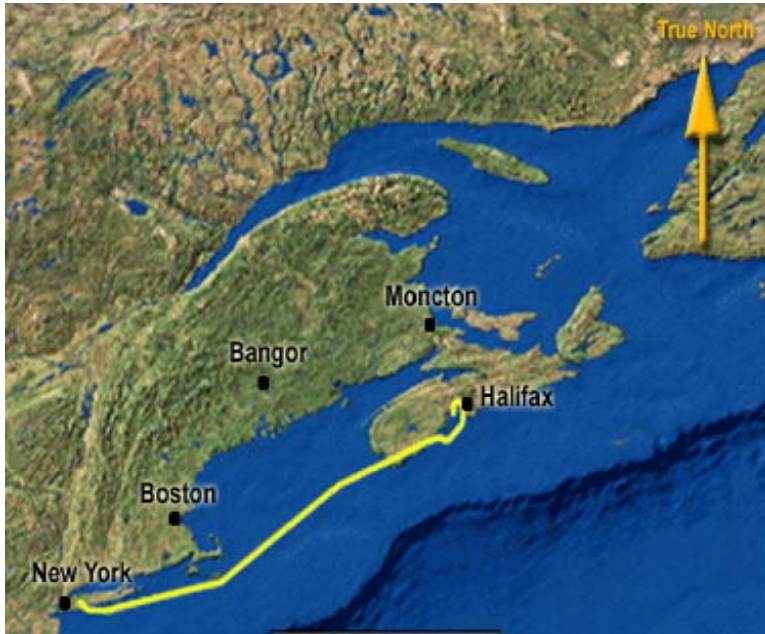
Actual SR 111 flight path

- 52 minutes after take-off, Captain and First Officer detect an unusual odor, then visible smoke in the cockpit
- Captain and First Officer agreed that the probable source was the air conditioning system – something crews had experienced before without fire or critical system effects
- Both pilots continue their deliberate – not immediate – actions, unaware of the fire raging in the cockpit attic space

- Smoke continued to build in the cockpit; Flight crew informed local air traffic control of an urgent (but not immediate) problem
- Pilots request clearance to divert back to Boston Logan International Airport, nearly 300 miles away
- Controllers suggest the closer Halifax Airport, only 60 miles away; Pilots immediately agree and begin initial descent

- With First Officer at flight controls, the Pilot began to work through checklist for smoke in the cockpit
- Non-essential power was cut-off, but smoke worsened; Loss of essential flight instruments soon followed
- As they believed they were too heavy to land safely, the pilots circle south of Halifax to descend further and dump fuel
- Pilots finally declare emergency, but nothing else is heard from the crew
- Six minutes later, SR111 crashes into ocean; only 21 minutes had elapsed since the crew first noticed the unusual odor
