# Deadly Efficiency:

## American Airlines Flight 191

### Leadership ViTS Meeting

July 2010

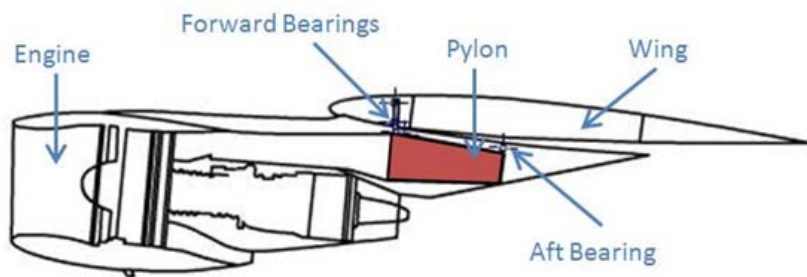
## McDonnell-Douglas DC-10

- Powered by three GE engines: one on each wing and one on the tail
- Wing-mounted engines were mounted onto pylons.
- Pylons were attached to wings via forward and aft bearings.

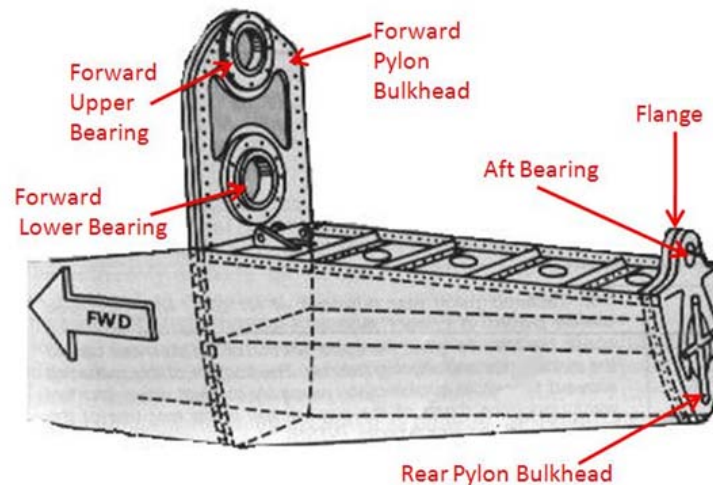
## Spherical Bearing Replacement

- McDonnell-Douglas issued two bulletins calling for replacement of the spherical bearings on the forward and aft bulkheads of the pylon.
