Brace for Impact:

MV Bright Field Allision

Leadership ViTS Meeting

October 2010

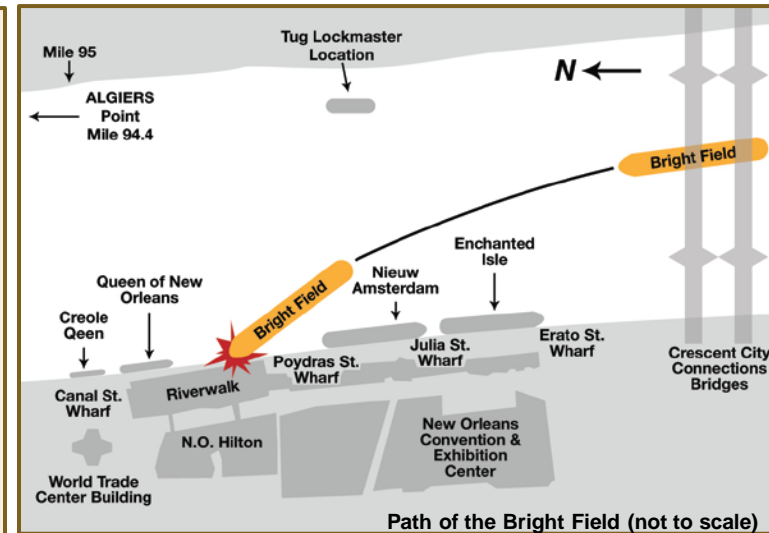
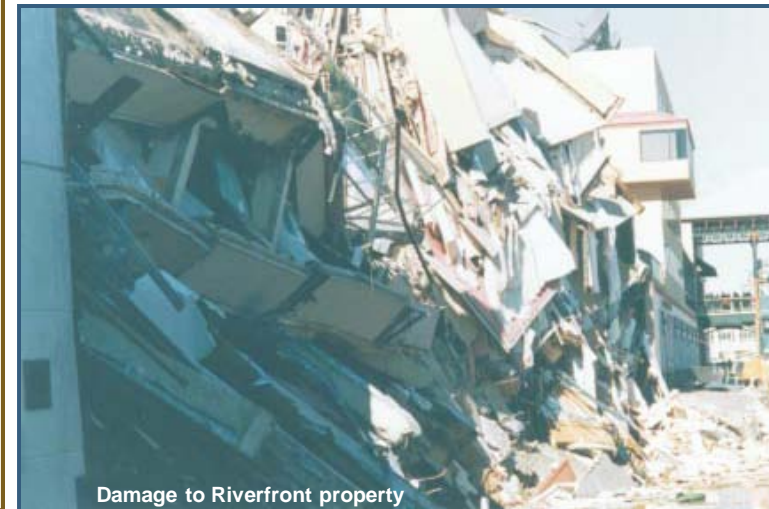
- Chief engineer observes engine oil pressure gauge dropping below normal levels.
- Backup pump fails to start and main engine shuts down.
- Just before rounding Algier's Point, the pilot notices that engine-induced vibrations have ceased.

- Pilot asks captain and 2nd mate if there is problem, but they ignore him and confer together in Chinese.
- Pilot notices rpm indicator has dropped from 72 to 30, indicating engine trip; pilot warns harbor of the situation.

- A crewmember manually starts the backup engine oil pump.
- Pressure rises to acceptable levels.
- Chief engineer restarts the main engine.
- 2nd mate calls engine room and demands immediate rpm increase, but does not transmit the urgency of the situation or instruct the chief engineer to use the "crash maneuver" button.

- Chief Engineer informs 2nd mate that engine power has been restored and transfers engine control to wheelhouse.
- *Bright Field* crashes into the Riverwalk.
