## SYSTEM FAILURE CASE STUDIES

OCTOBER 2010 VOLUME 4 ISSUE 10

# Brace for Impact

### Liberian Bulk Carrier Allides With Riverfront Mall: 67 Injured.

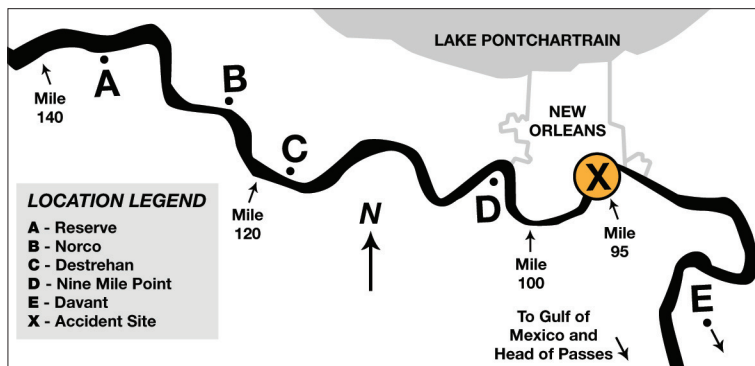
**Figure 2: Distances along the Mississippi are measured in miles “above head of Passes.” Head of Passes is where the river branches as it spills into the Gulf of Mexico.**

The Port of New Orleans stretches from mile 88 to mile 120 above Head of Passes (AHP, Figure 2). A major attraction in the Port of New Orleans is the Riverwalk, a mile-long stretch of property containing shops, restaurants, and other amusements. The area affords sightseers an up-close view of passing ships: fourteen thousand deep draft vessels such as the *Bright Field* pass the Riverwalk each year. Maneuvering large freighters through the Lower Mississippi’s twists is uniquely challenging; therefore Louisiana State law mandates foreign trade vessels to have a certified State pilot on board when sailing in State waters. River pilots are dispatched by the New Orleans Baton Rouge Steamship Pilots Association (NOBRA) or similar pilot associations.
