Got Any Ideas?:

U.S. Airways Flight 1549

Leadership ViTS Meeting

April 2011

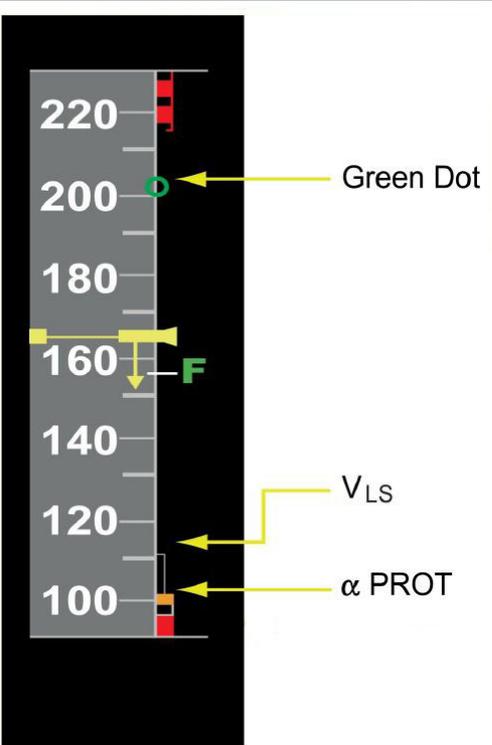
Airbus A320 Airspeed Scale

- Green Dot: Represents the speed at which the aircraft must travel to obtain the best lift over drag ratio, allowing maximum range for glided flight.
- V_{LS}: Lowest selectable speed at which the aircraft can travel while still generating lift.
- α-protection: Prevents the aircraft from stalling, but only activates when the aircraft is flying under Normal Law.
