SYSTEM FAILURE CASE STUDIES

JULY 2011 VOLUME 5 ISSUE 7

Communication Aberration

Optical Systems Failure on Hubble Cripples Data Collection

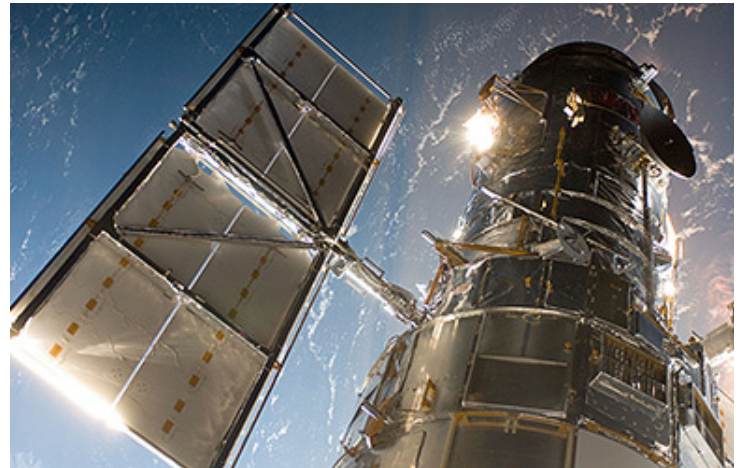
Figure 1: Hubble's vantage point in low-earth orbit allows it to collect a wider range of wavelengths than ground-based telescopes, and the images it captures are free from the atmosphere's distorting effects.

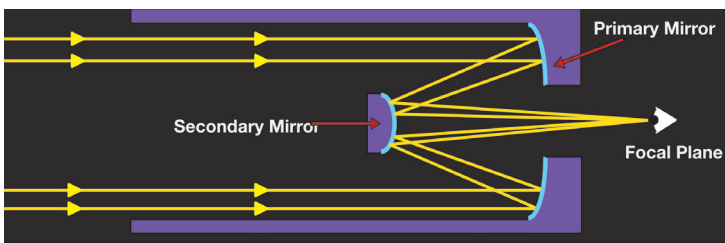
Figure 2: Light path through a reflecting telescope
