# Loss of Detection:

## *D.C. Metro Railway Collision*

### Leadership ViTS Meeting

August 2011

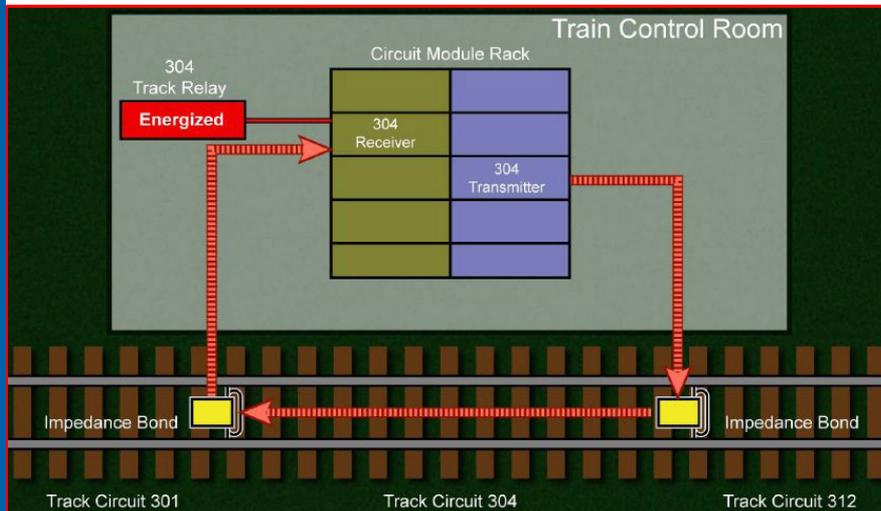
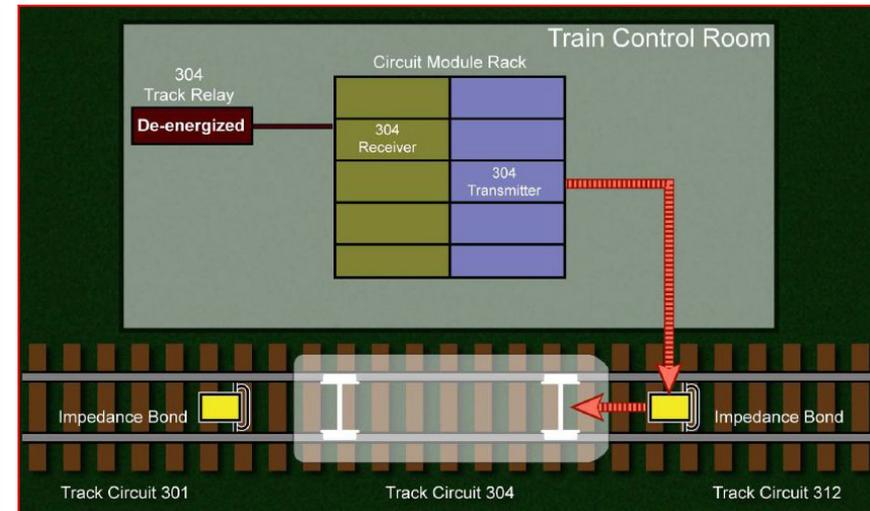
**Track circuit modules are located in a control room at the nearest train station. The module transmitter sends a signal to the corresponding impedance bond, which passes the signal through the rails to the adjacent impedance bond. From there, the signal travels back to the control room to the module receiver, energizing the track circuit. When trains occupy the track, the signal never reaches the module receiver, and the track circuit de-energizes, indicating it is occupied (Credit: NTSB)**
