## SYSTEM FAILURE CASE STUDIES

JANUARY 2012 VOLUME 6 ISSUE 1

# Safe Anyway

#### British Reconnaissance Aircraft Crashes over Afghanistan, 14 Dead.

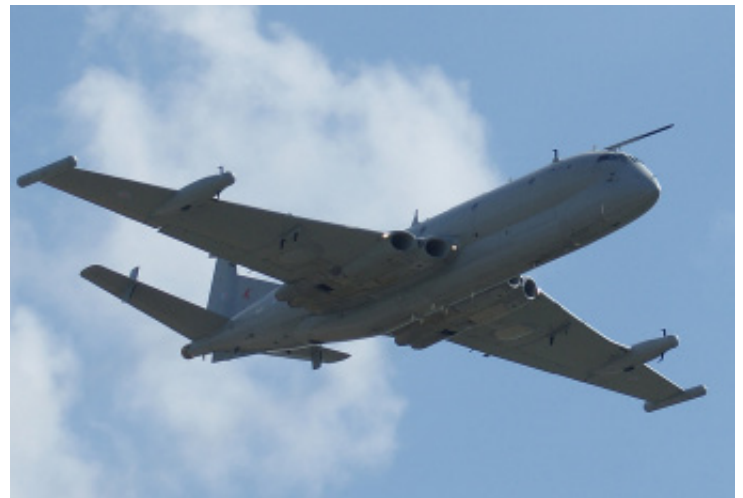
**Figure 1:** Nimrod in flight. Paired engines can be seen embedded in the wings, close to where the wings connect to the fuselage.
