SYSTEM FAILURE CASE STUDIES

Out of Line

Gas line ruptures, causes explosion in California suburb: 8 dead.

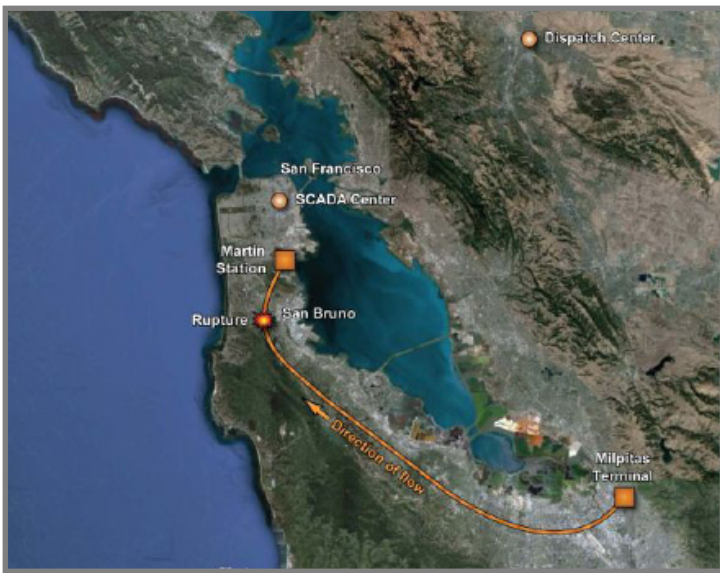
One of five lines that originate at Milpitas Terminal, Line 132 extends north for 46 miles to Martin Station. Line 132 connects to Lines 101 and 109 at many locations, which also service the peninsula region (Figure 2). Milpitas is an unmanned station that

Figure 2: Line 132 originates at Milpitas Terminal and ends at Martin Station.
