A Loaded Magazine

The Honolulu Fireworks Disposal Explosion

Senior Management ViTS Meeting

July 2013

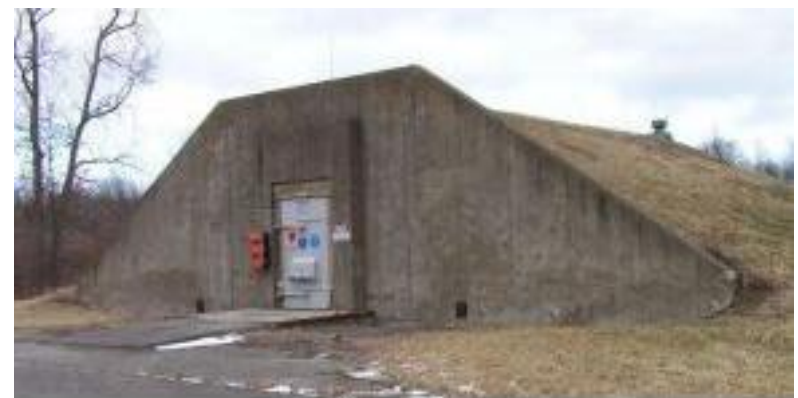
One of 99 bunkers built at Plum Brook Station by the Army during WWII, currently used and operated by the Glenn Research Center (GRC). Source: IG Report.
