NASA Quality Leadership Forum

Premature Wear of the “Curiosity” Mars Rover Wheels

March 13, 2019

Jet Propulsion Laboratory, California Institute of Technology

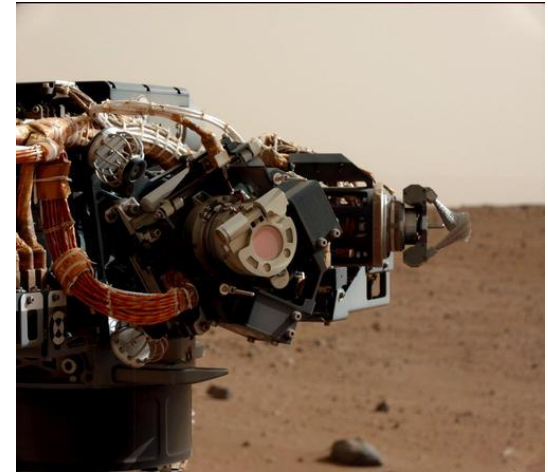
- MAHLI camera on the rover's robotic arm periodically checks the condition of the wheels →

- ← Detail view of the inner surface of Curiosity's left front wheel on sol 411. Arrow points to tear

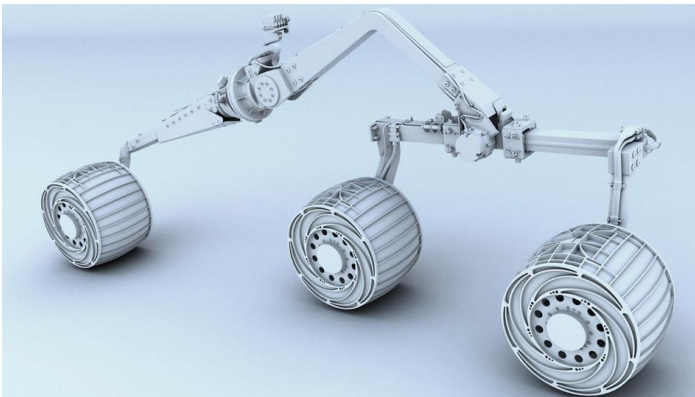
- The impact of ventifacts is exacerbated by a dynamic mechanical load on the wheels

The rocker-bogie mobility system (the wheels surmounts the face of a vertical obstacle (rock) by having the center and rear wheels force the front wheels against the obstacle

- Corrective actions to prevent further wheel damage:
 - Track wear progression and drive so as to minimize wear
 - Avoid hard surfaces and ventifacts
 - Drive backwards on “wheel hostile” terrain
- These measures have proven effective in managing the rate of damage: the rover will be able to complete its extended mission-- and likely further mission extensions
 - Will slow Curiosity’s progress and limit it’s paths

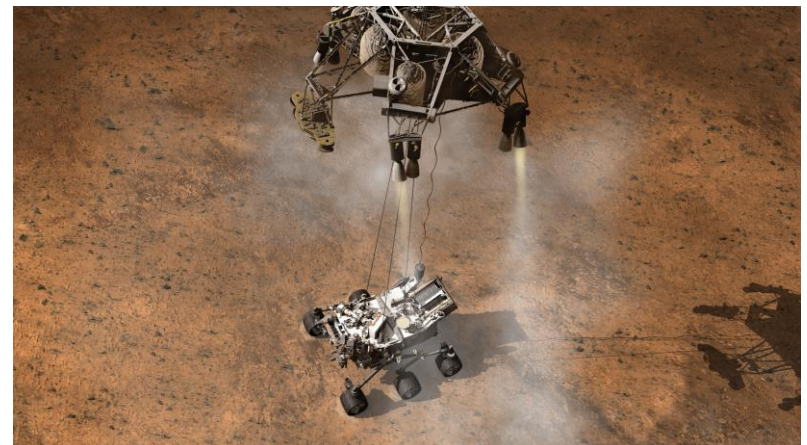
Landing touchdown loads were expected to be the worst case wheel failure mode →
