Lessons from Balloon Experimental Twin Telescope for Infrared Interferometry (BETTII) Close Call

Balloon Experimental Twin Telescope for Infrared Interferometry (BETTII)

Mishap Investigation Performed per NPR 8621.1

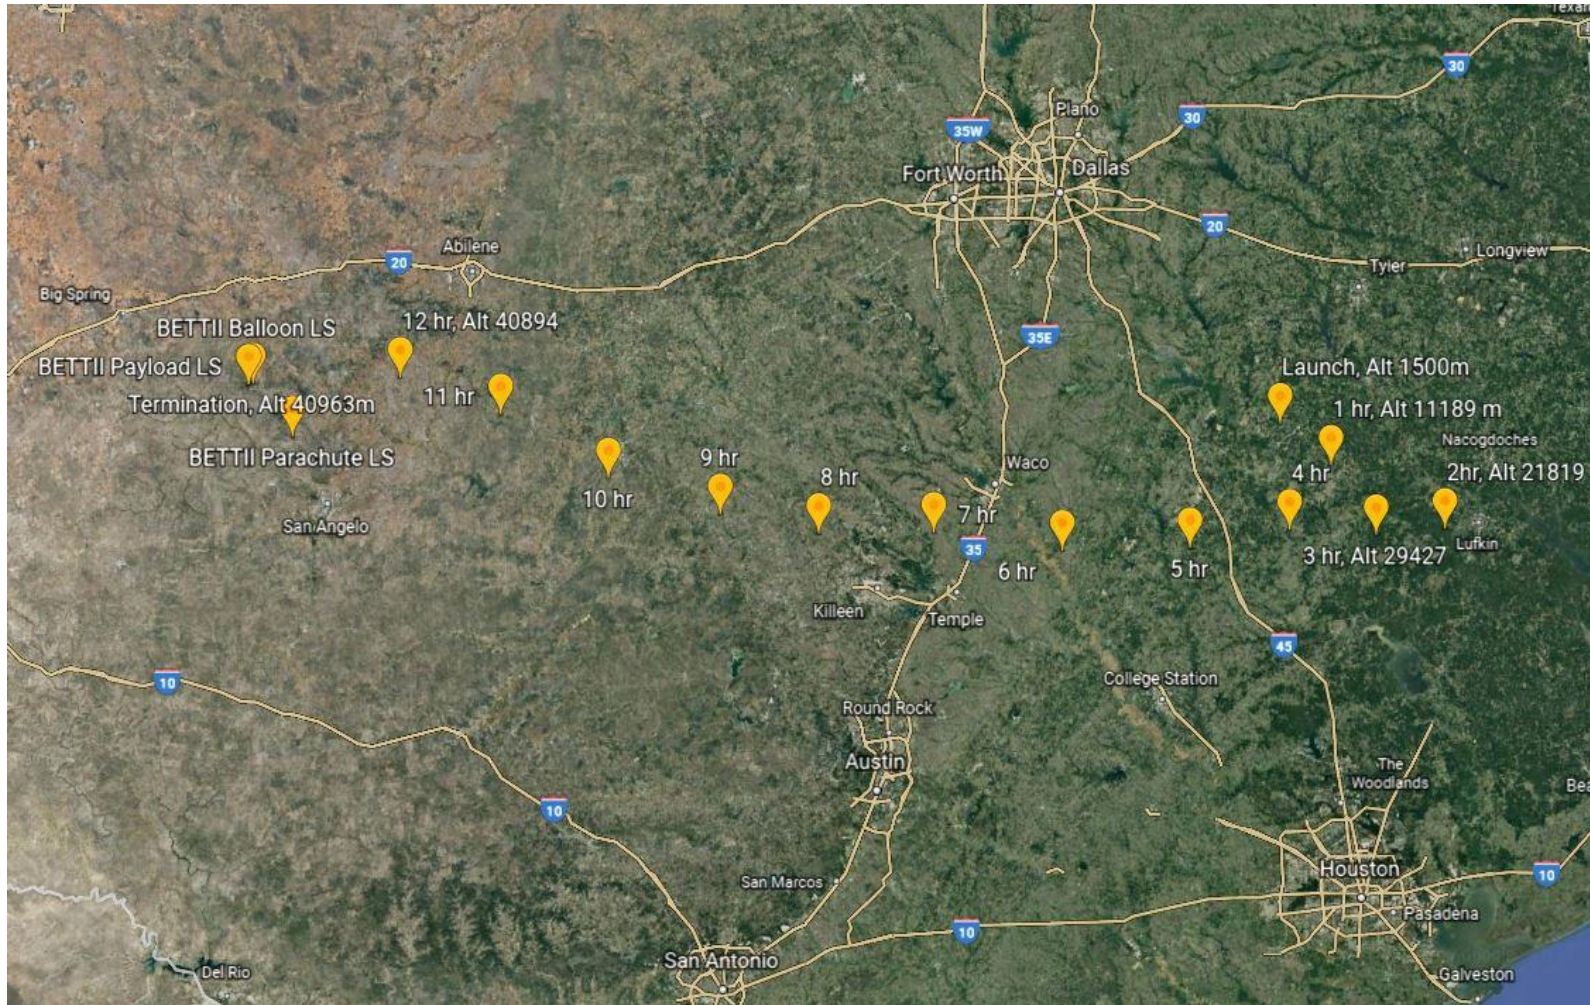
BETTII Flight Path

BETTII-Balloon Flight 1598P lasted 12 hours and tracked approximately 300 miles across Texas.

On the morning of June 9, at 7:35am Flight 1598P was sent the command to terminate. After termination, there was an immediate loss of telemetry from BETTII.

This was anomalous as the telemetry is typically received until parachute is below the horizon

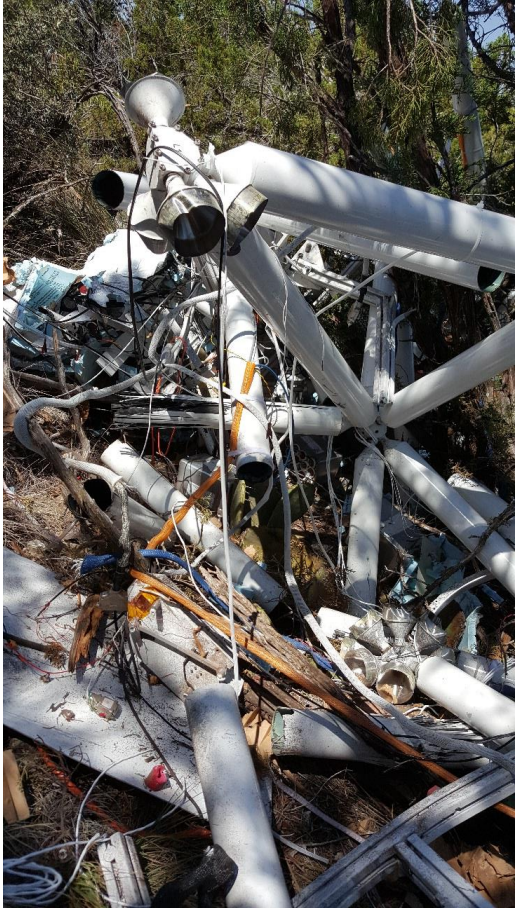
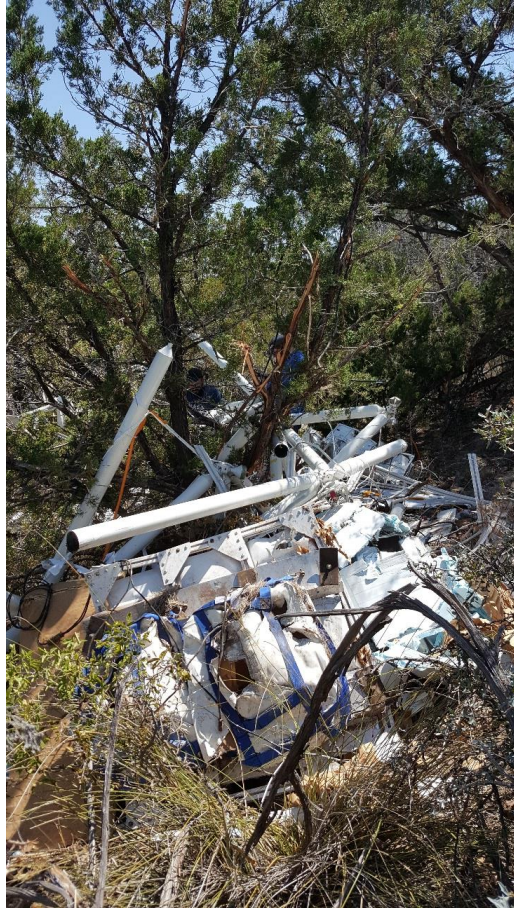
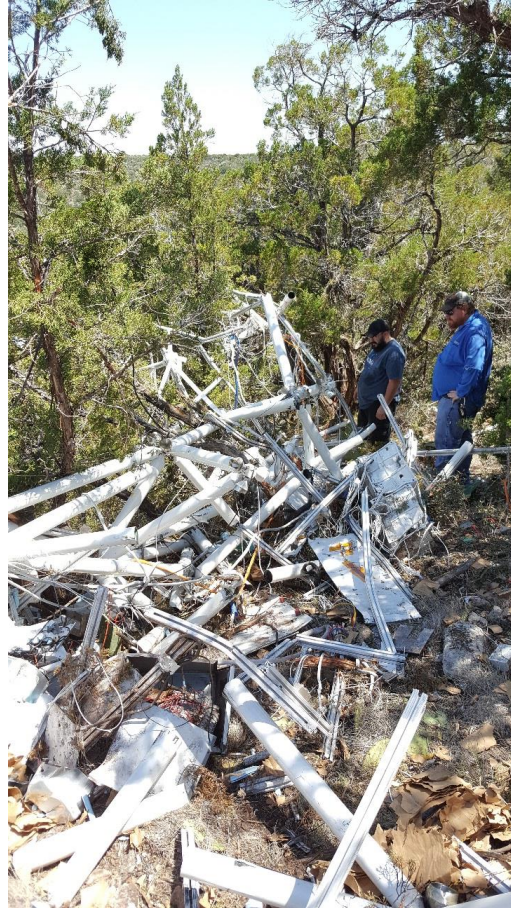
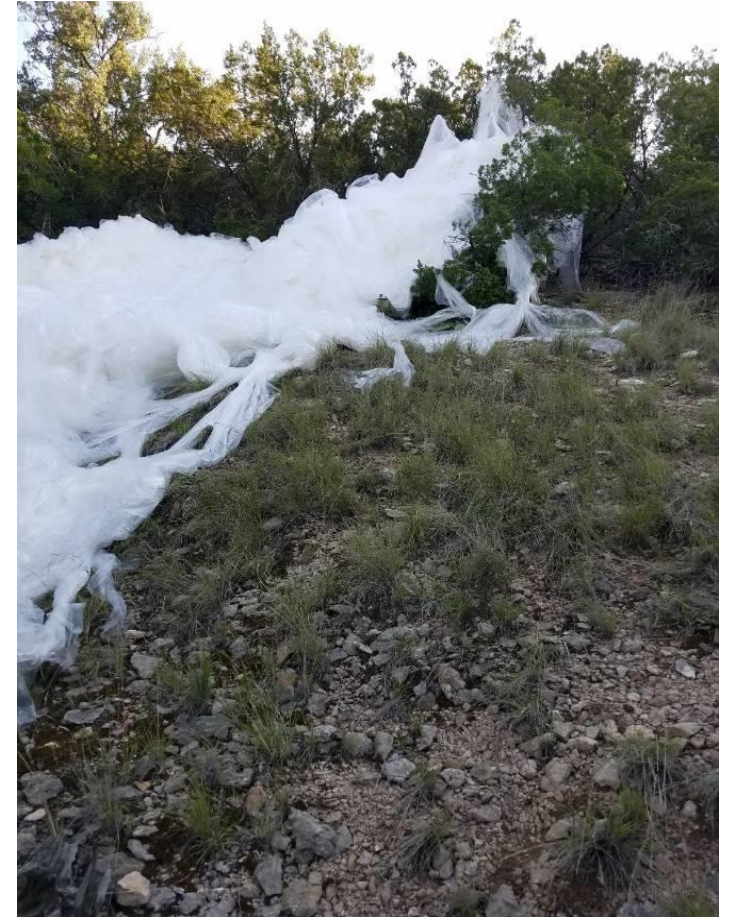
BETTII Gondola and Balloon Landing Site

The BETTII payload was located approximately $\frac{3}{4}$ mile southwest of the termination site.

Due to the remote location the BETTII hardware had to be transported via helicopter.
