Vapor Trap

The Xcel Energy Confined Space Penstock Fire

Senior Management ViTS Meeting

December 2012

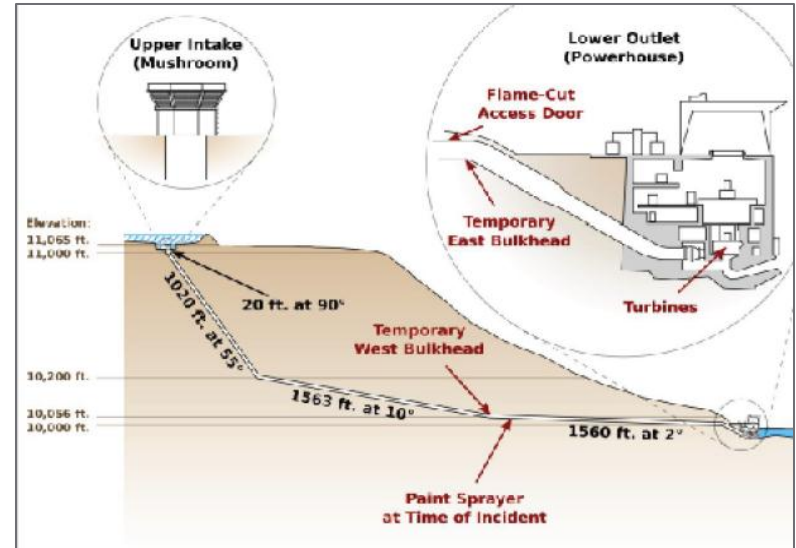
The Penstock at Cabin Creek

- The steel penstock (or pipeline) at the Xcel Energy (Xcel) Cabin Creek facility stretches 4,163 ft from the upper reservoir intake to the powerhouse turbines.
- It is a permit-required confined space as defined by the Occupational Safety and Health Administration (OSHA) (29 CFR 1910.146).

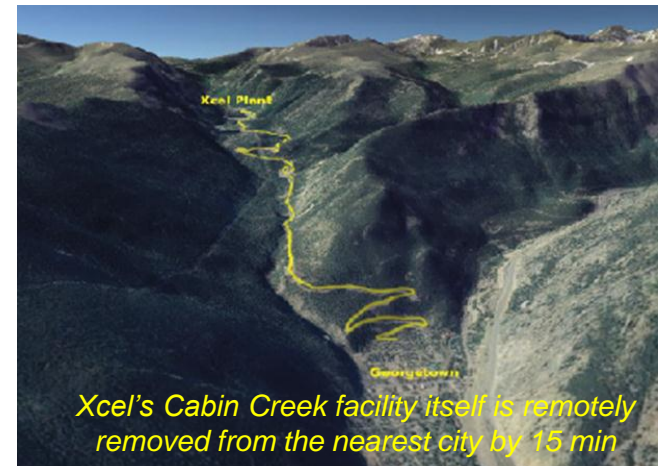
- Oct. 2, 2007, RPI painters inside the penstock stopped to clean the epoxy sprayer with MEK.
- Vapors ignited “likely from a static spark” (CSB Report)—separating the workers by fire.

- Five of the nine workers were blocked from the exit and trapped by the fire in the narrow space.
- Four were located on the side of the fire nearest the access point (1,450 feet away) and ran for help.
