NASA SAFETY CENTER
SYSTEM FAILURE CASE STUDY

Vapor Trap

The Xcel Energy Confined Space Penstock Fire

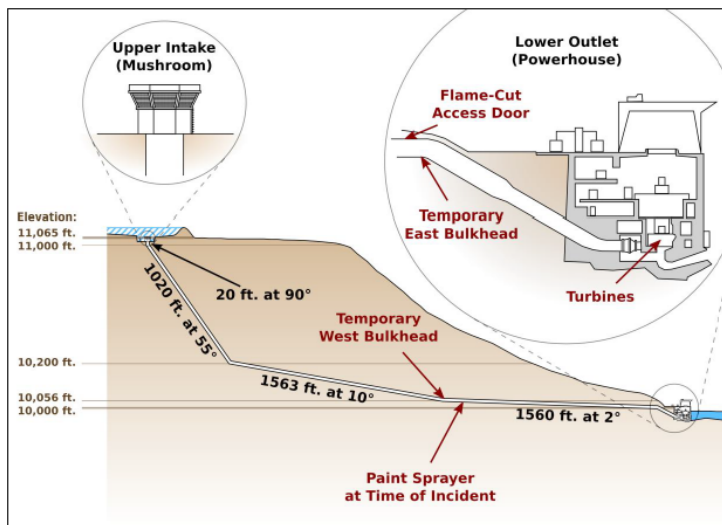
Figure 1. A cutaway view of the penstock at Xcel's Cabin Creek facility. Source: CSB

A penstock is a conduit or pipeline that regulates water flow from the reservoir or water source in hydroelectric power plants and water-operated mills. The steel penstock at the Xcel Energy (Xcel) Cabin Creek facility stretches 4,163 feet from the upper reservoir intake to the powerhouse turbines. The lower, near-level (inclined between 2 and 10 degrees) 3,123-foot section is negotiable on foot. Approximately 15 feet of this near-level portion is exposed above ground where the penstock couples with the powerhouse. The remaining 1,040-foot segment of the penstock has significant gradients of 55 and 90 degrees and requires climbing aids to traverse.

The upper reservoir intake is known as the “mushroom,” a 40-foot tall, steel and

concrete structure with screen openings and an access hatch positioned in a reverse incline around the top. Due to this positioning, once the reservoir is drained, individuals require significant physical strength, climbing skills, and equipment to access the mushroom.

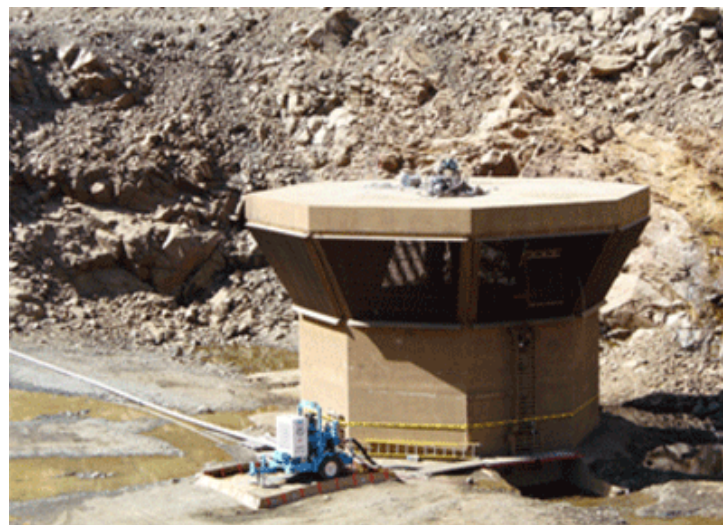
Figure 2. The upper intake, or "mushroom," sits in the upper reservoir of the Cabin Creek facility. Source: CSB
