**ANALYSIS OF
APOLLO 12 LIGHTNING INCIDENT**

MARSHALL SPACE FLIGHT CENTER

KENNEDY SPACE CENTER

MANNED SPACECRAFT CENTER

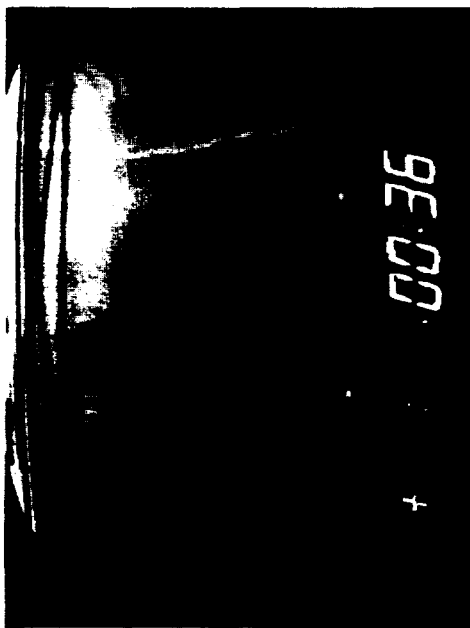
Figure 1.- Sequence photographs of television scans of the lightning strike at 36.5 seconds.

Note: Each scan has 1/60 - second exposure time with one millisecond between each scan.

Four motion picture cameras recorded lightning discharge channels near the launch tower. These photographs, together with video-tape records from the abort advisory television camera (figs. 1 and 2), show two discharge channels. The duration of each scan in figure 1 is 1/60 second with 1 millisecond between scans. These photographs were obtained from video-tape records of the actual event. The bright lightning channel apparently saturated the vidicon tube in scan b, and the tube remained saturated for scans c and d. The image began decaying in scan e and required four scans for total decay. Scan f shows the second lightning channel, which developed approximately 60 milliseconds after the first. One of the channels, located about 1500 feet from the launch umbilical tower, showed pronounced downward branching and appeared to last 50 milliseconds in the motion picture photographs. Another channel, partly obscured by steam and clouds and about 100 feet from the launch umbilical tower, also lasted about 50 milliseconds. One frame from each of the motion picture cameras that recorded the lightning strike at 36.5 seconds are shown in figure 3.

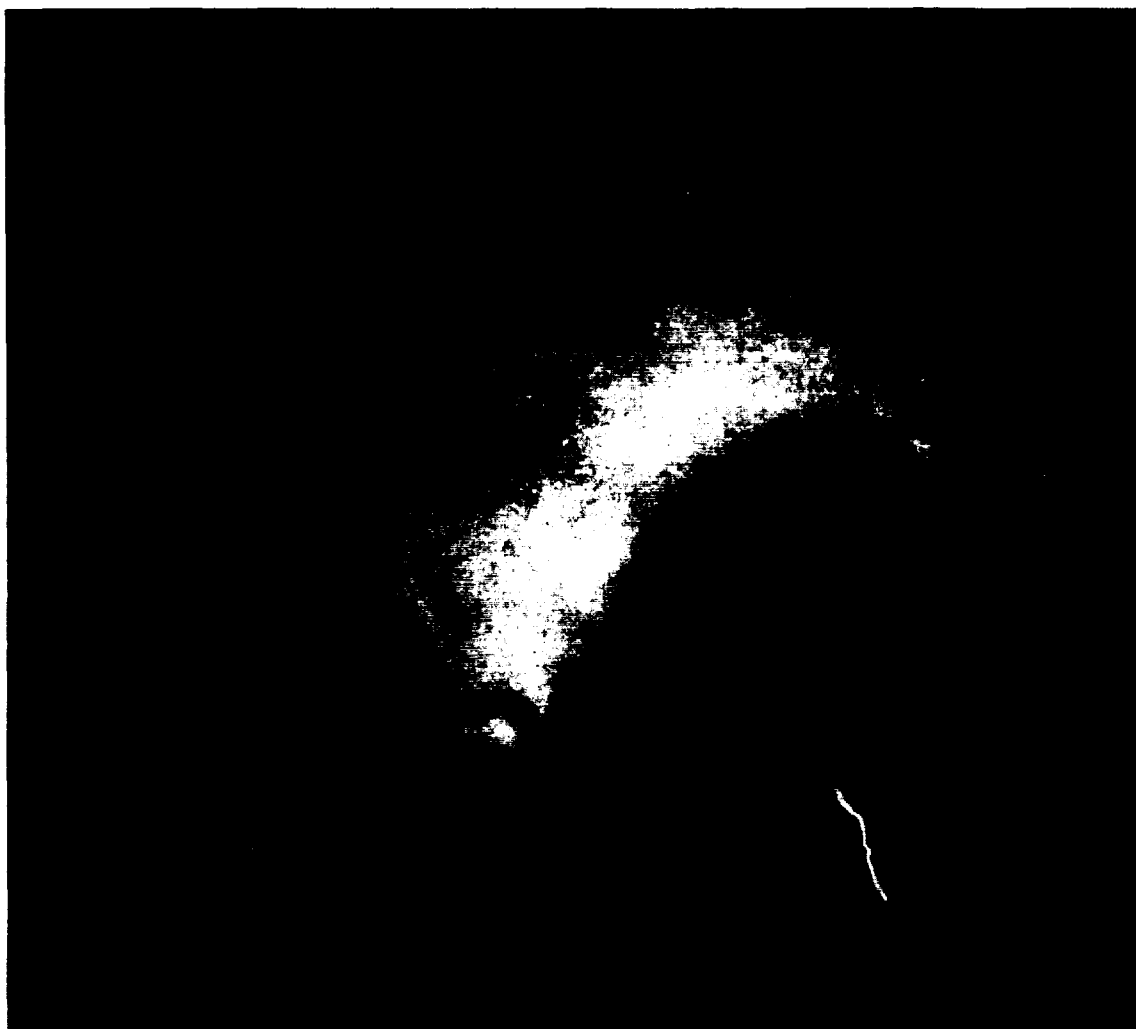
(a) Camera E-100.

Figure 3.- Additional photographic evidence of lightning discharge.

(b) Camera E-102.

(c) Nevada all-sky camera.

^bNevada all-sky camera photograph is a 360-degree view looking straight up. This camera and the photograph in figure 3 were provided through the courtesy of Dr. O. Richard Norton, Curator of Fleischmann Atmospherium-Planetarium, Desert Research Institute, University of Nevada, Reno, Nevada.

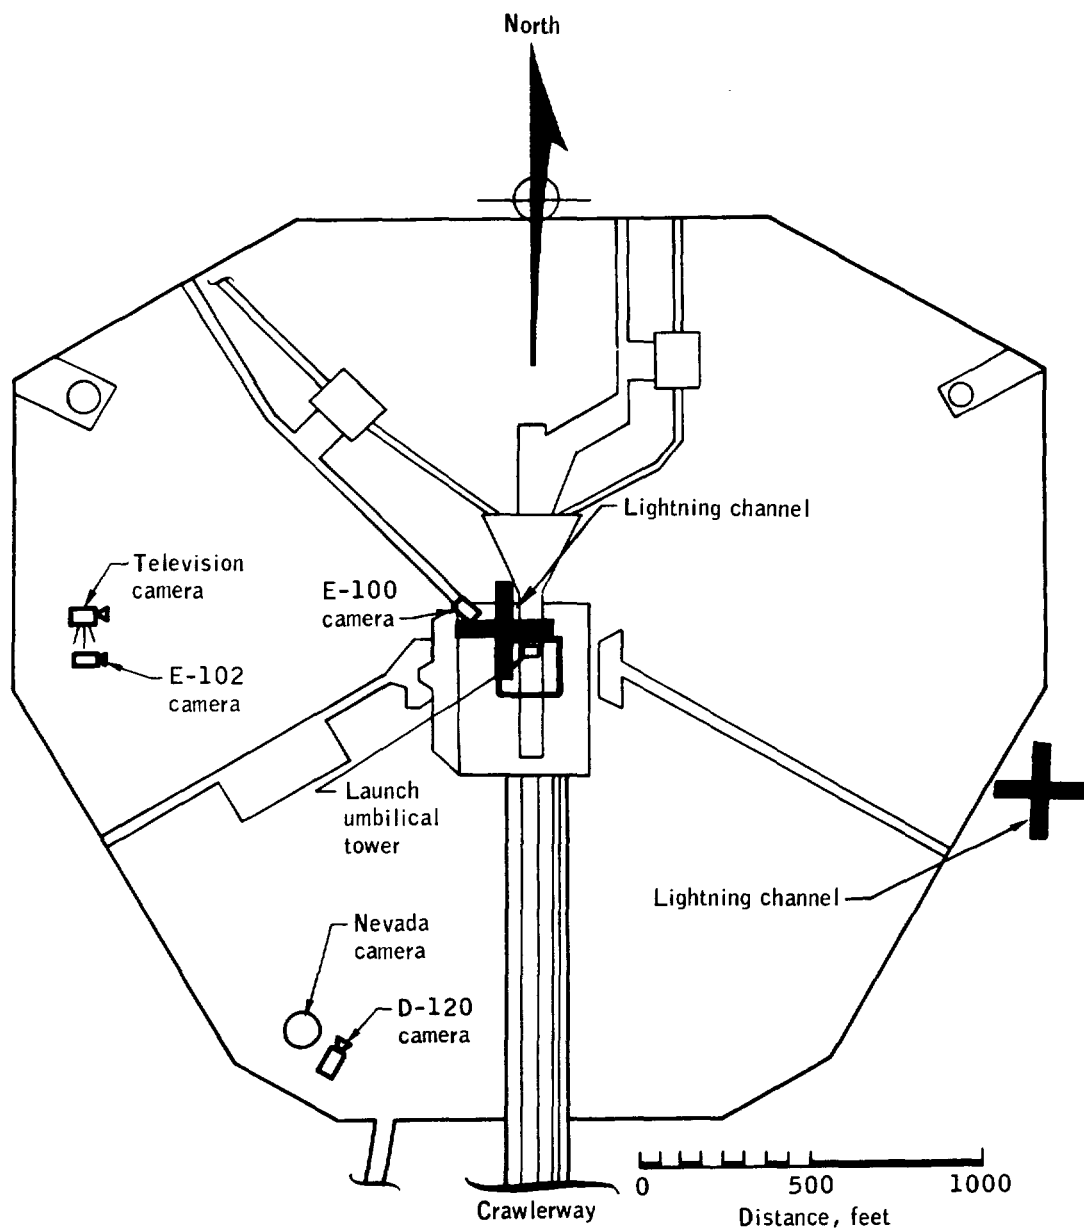
Figure 4.- Camera locations and lightning channels on launch complex 39A.

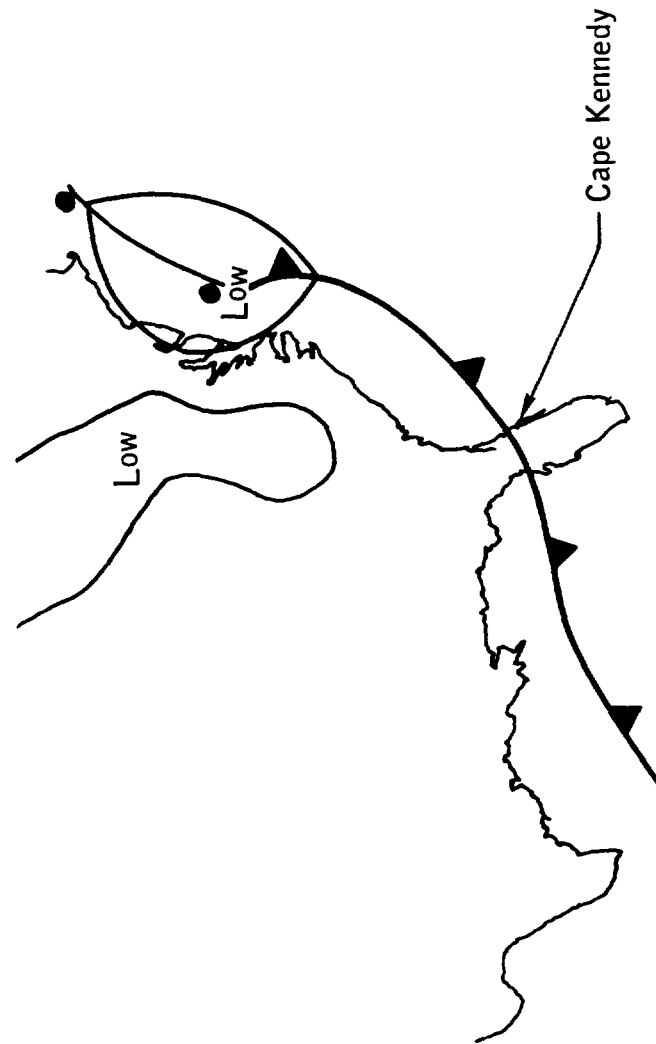
Figure 5.- Frontal location four hours prior to launch.

At the time of launch (11:22 a.m. e.s.t.), the cold front was passing through the Kennedy Space Center. Radar echoes extended across Florida from northeast of the Cape Kennedy area and averaged 20 miles in width, although in places the band of echoes was 30 miles wide. Tops of the cumulus congestus clouds reached a maximum of 23 000 feet within a range of 30 miles, according to radar operators' reports. Winds aloft were southwest or west-southwest from 3000 to 50 000 feet, and speed ranged from 36 knots at 3000 feet to a maximum of 90 knots at 47 000 feet. The general weather conditions in the vicinity of the launch complex were highly variable with clouds reported between 800 and 1500 feet and the overcast between about 2000 and 10 000 feet. There were light rainshowers with southwest winds. Detail weather conditions in the area are shown in table II. Less than an hour after launch, the precipitation had ended in the launch complex area and the skies were clearing as the cold front moved southeastwardly during the remainder of the day. The frontal location 4 hours prior to launch is shown in figure 5.

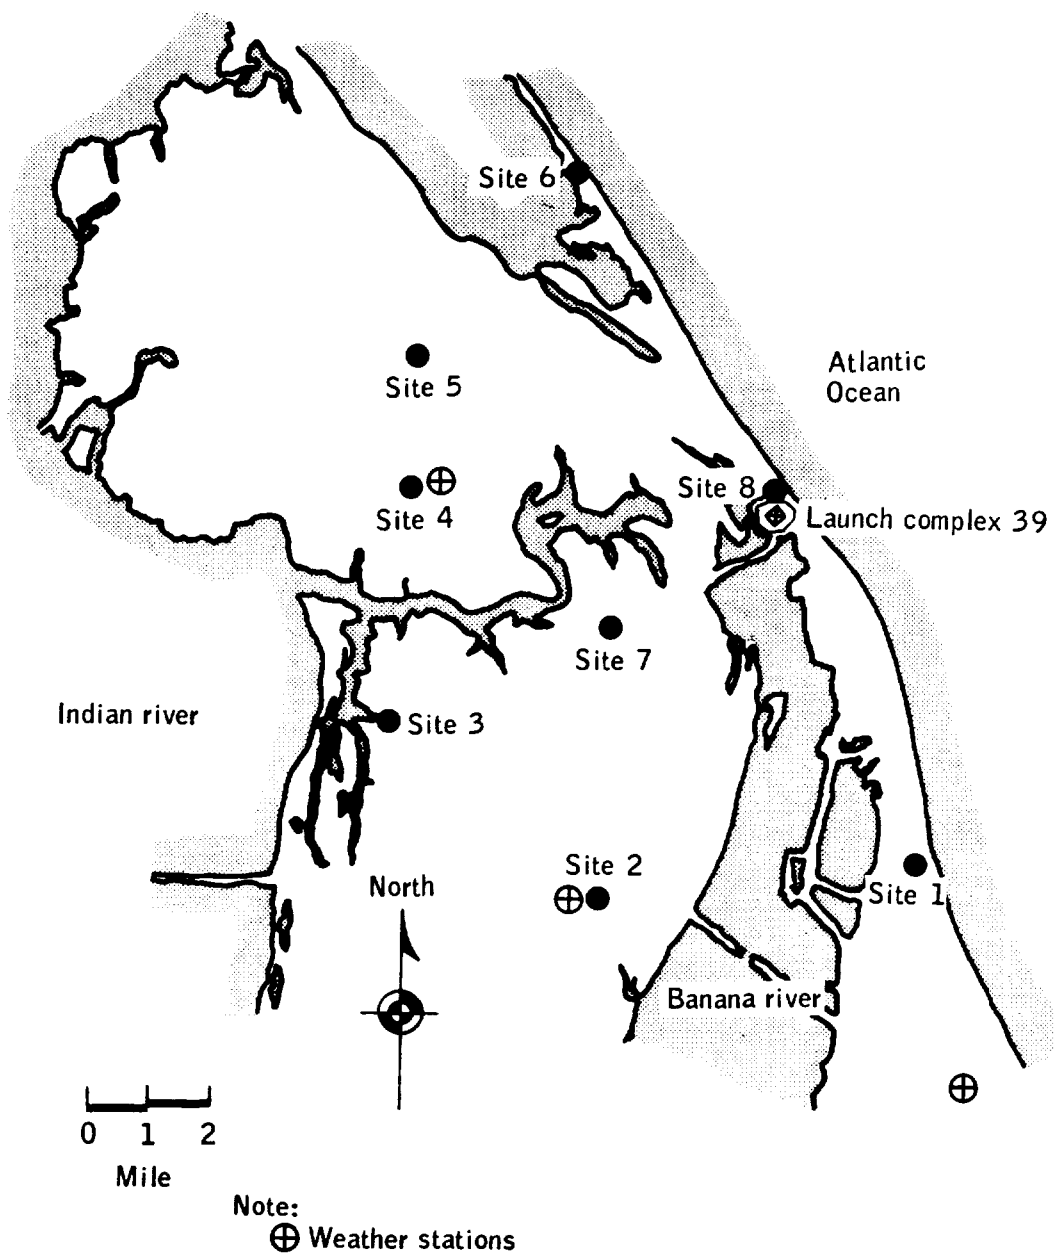
Figure 6.- Location sites for lightning instrumentation.

Traces of the potential gradient measurements taken by eight radioactive devices (fig. 6) during the final countdown period are shown in figure 7. The instrumentation description is given in Appendix A. The traces in figure 7 show a variability in frequency and magnitude of the potential gradient at the point of measurement and are indicative of rapidly and highly fluctuating electric fields above the launch complex area. It should be noted that the devices are calibrated in the laboratory. No additional corrections, such as for wind or exposure, have been applied to the data. The tabulated potential gradient readings were as follows:

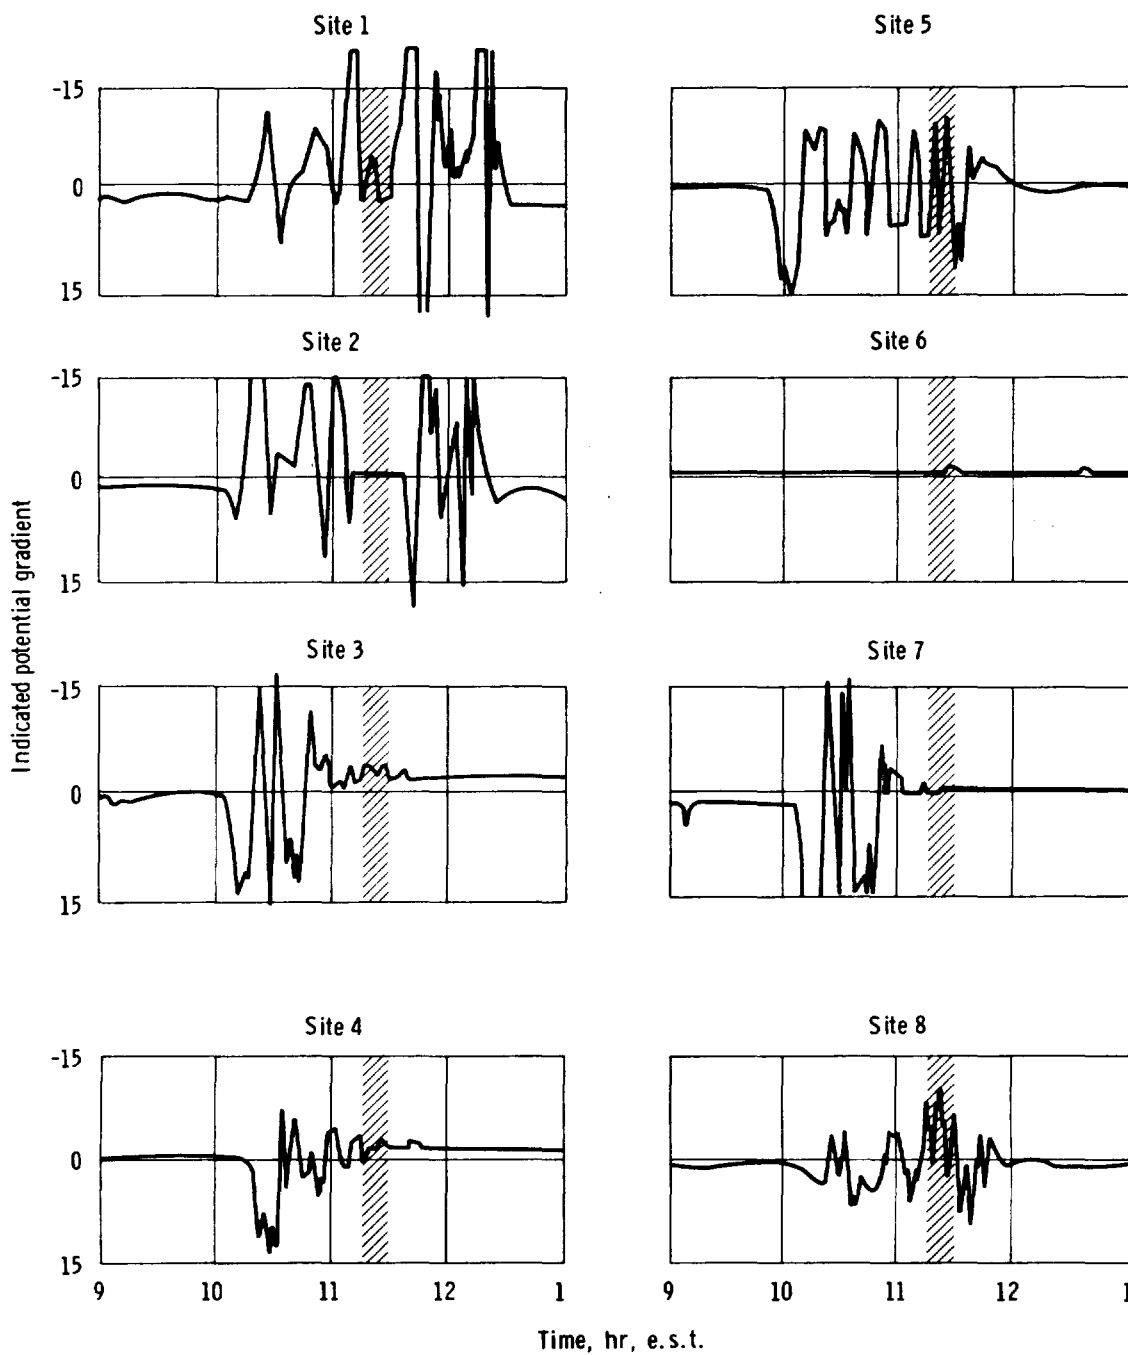
Note: These data show trends of the potential gradient during launch day.

Time of launch; width of band indicates time uncertainty of the trace.

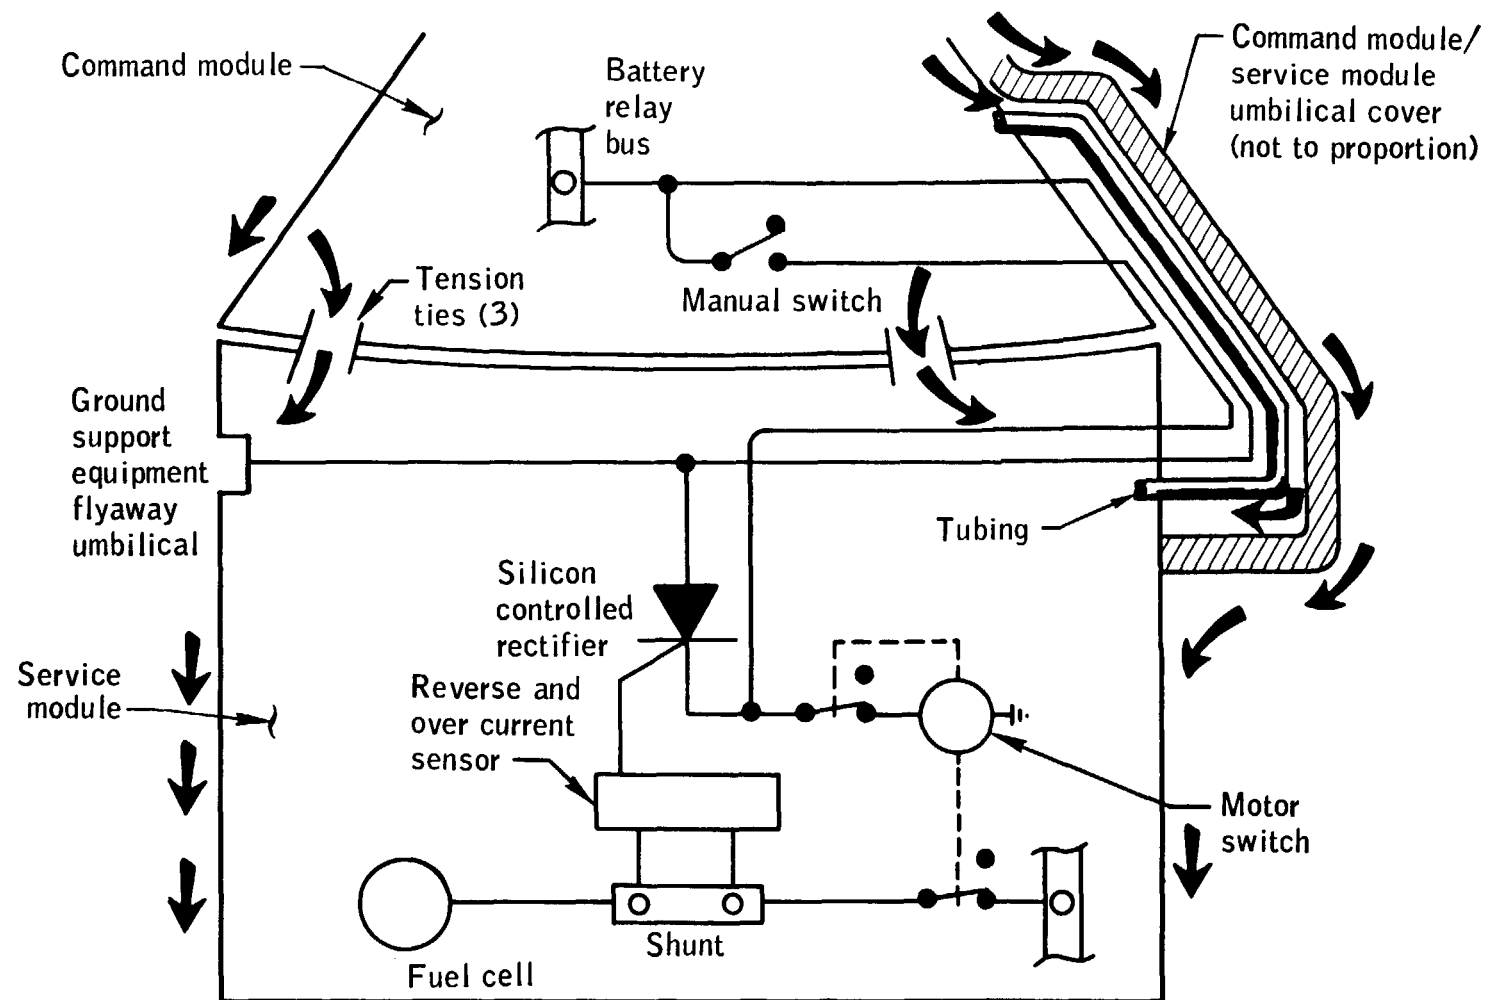
Fuel cells.- At about 36.5 seconds, the fuel cells were abruptly and automatically disconnected from the spacecraft power buses, with the resultant alarms normally associated with total fuel cell disconnection. The basic elements that are typical for each of the three fuel cells associated with the automatic fuel cell disconnection circuitry and switches are shown in figure 8. Automatic disconnection of the fuel cells takes place when sufficient current flows through the shunt. If the current exceeds a certain value, the integrating circuit within the disconnect circuitry will gate ON the silicon controlled rectifier. For example, if 300 amperes were applied through the shunt, the integrating circuit would require between 1 and 3 seconds to reach the threshold of the circuit and gate ON the silicon controlled rectifier. Once the rectifier is gated ON, current will flow from the bus to the motor-driven switch, which requires 0.1 second to disconnect the fuel cells from the bus. The likelihood of a high current flow through the shunt causing the disconnect can be ruled out for several reasons but primarily because the fuel cells simply cannot supply the energy levels required by the integrating circuit to gate ON the silicon controlled rectifier in a time frame of milliseconds.

A silicon controlled rectifier has the characteristic of being sensitive to the rate of voltage change (dV/dt) on the anode (power side). The rectifiers in the disconnect circuit will gate ON without a gating signal if 500 V/microsecond is imposed on the anode or if the anode voltage exceeds 200 volts. The rate of voltage rise for a lightning discharge is consistent with the 500 V/microsecond value. If the turn on mechanism was due to exceeding 200 volts (breakover voltage) on the rectifier anode,

Figure 8.- Fuel cell disconnect circuitry.

it is likely that the rectifier would have been damaged. However, the rectifiers were not damaged as verified by the successful reconnection of fuel cells to the buses. This characteristic provides the suspected mechanism (as dV/dt) for initiating the fuel cell disconnects. Figure 8 shows two methods in which a high rate of potential change could have been imposed on the power line to the rectifier. The most likely method would be induction as a result of the discharge transient through the conducting path of the structure in the area of the umbilical cover. The other is a direct input through a wire connected to an exterior umbilical.

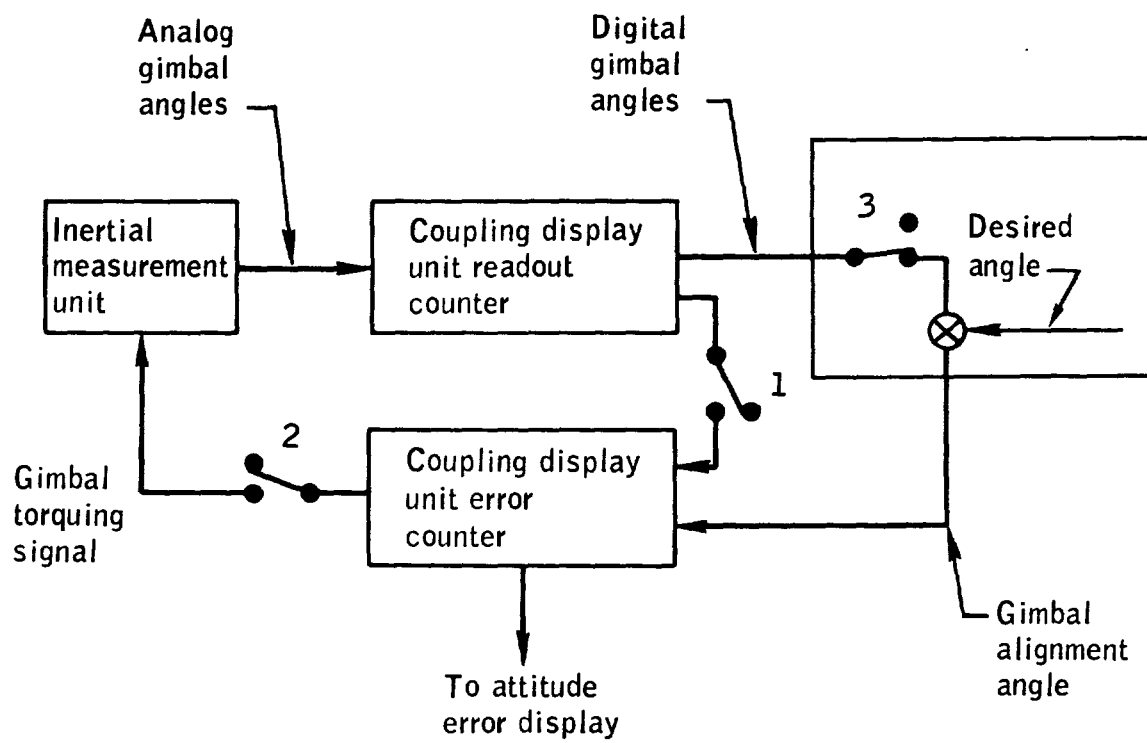
A simplified functional diagram of the system is shown in figure 9. In the launch configuration, switch 3 is closed and the computer receives gimbal angle data from the coupling display unit. These data are compared to the planned launch trajectory, and the angle differences are displayed to the crew through the coupling display unit error counter. Switches 1 and 2 are open for launch, but are closed when the computer enters the coarse align mode. Normally in this mode, the computer supplies the angle data that the coupling display unit error loop must null by driving the gimbals, but the coupling display unit will not affect the angles requested by the computer. However, when switch 3 is closed (launch configuration) and switch 1 and 2 are also closed, a condition exists in which the computer-requested gimbal angles will continuously be changed by the readout so that the error loop cannot be nulled. If there is a large difference

Figure 9.- Simplified functional diagram of the computer/inertial measurement unit interface.

The most likely cause of the tumbling condition was the setting of high-order bits in the coupling display unit as a result of the voltage transients introduced into the circuits. At 52 seconds, however, the Z-axis coupling display unit (middle gimbal) was also affected such that the readout exceeded 85 degrees. At 85 degrees the computer, sensing impending gimbal lock, will automatically change the platform to the coarse align mode. Under these conditions, the inertial measurement unit/coupling display unit servo loop becomes unstable and continuously drives the gimbals.

between the coupling display unit and platform angle when entering coarse align, regardless of the computer output, the platform will become unstable. This condition has been demonstrated in a bench test of the system simulating the observed conditions.

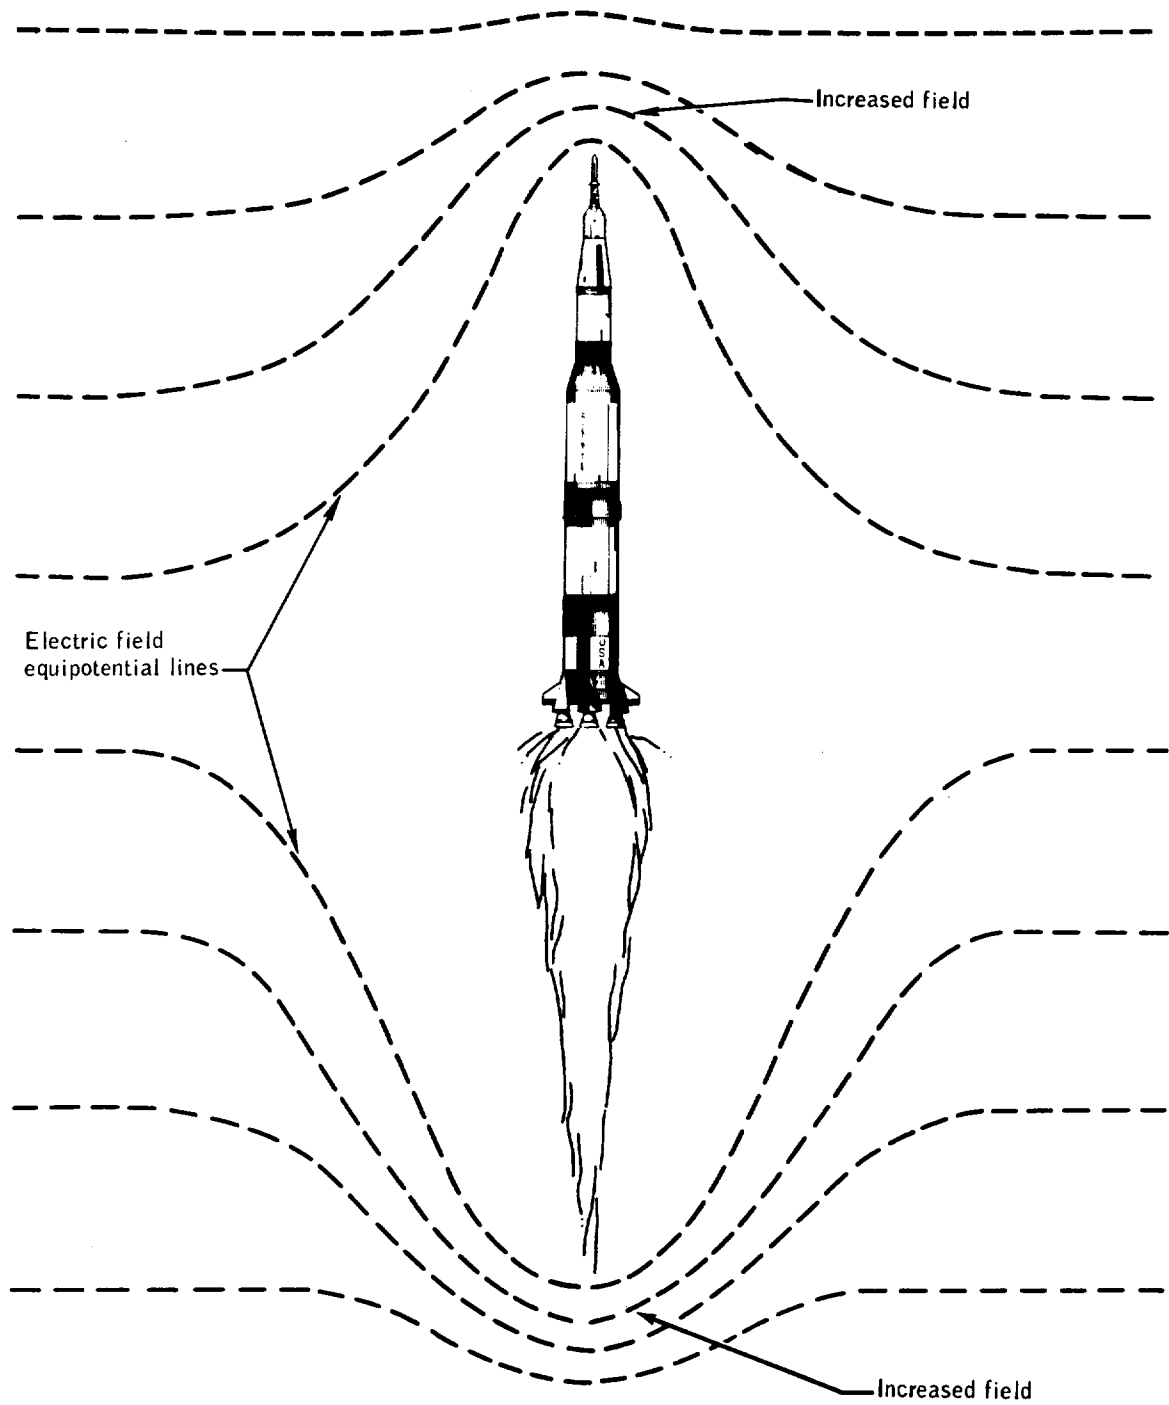
Figure 10.- Enhancement of electric fields at each end of the space vehicle.

When the enhanced electric field becomes sufficiently large (about 3×10^6 V/m for air at sea level, less at high altitudes), electrical breakdown will occur and may be propagated either up or down, or both ways. Following the initial breakdown, a discharge may develop in a manner similar to natural lightning.

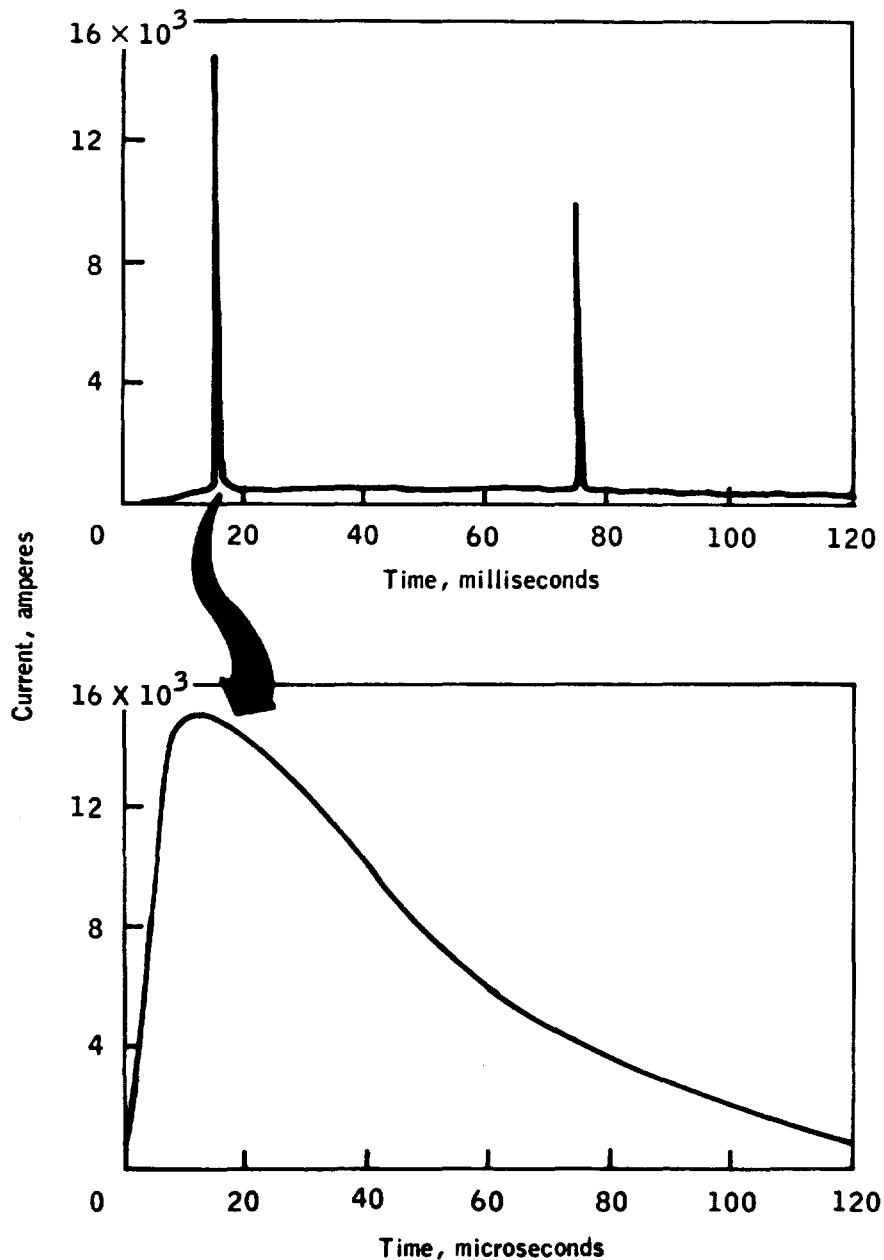
An indication of what might have been the discharge current at the vehicle is shown in figure 11. This estimate is based on the nature of the lightning recorded on film and on currents measured during other triggered discharges and natural lightning.

Figure 11.- Probable current characteristics of the discharge at 36.5 seconds seen at the space vehicle.

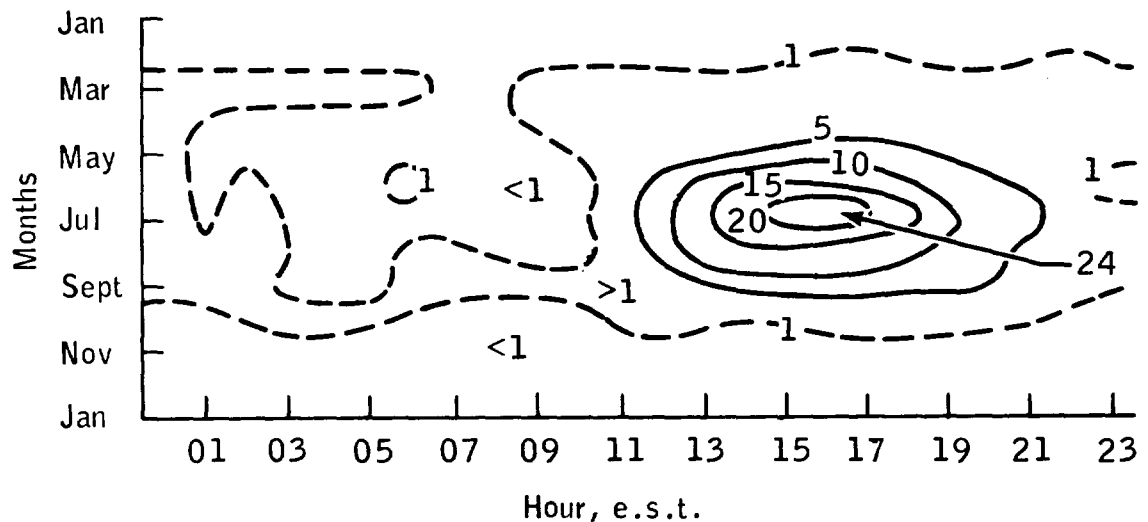
Note: All values shown are in percent.

Figure 12.- Probability of thunderstorm occurrence by months plotted against time of day in the Cape Kennedy area.

Because of the high frequency of thunderstorm occurrence in the Cape Kennedy area, a comprehensive review has been performed of typical conditions associated with potentially dangerous electric fields. This basic information was required prior to definition and evaluation of realistic launch rules. The frequency of thunderstorm conditions in the Eastern Test Range area is shown in figure 12 (see reference 5.)

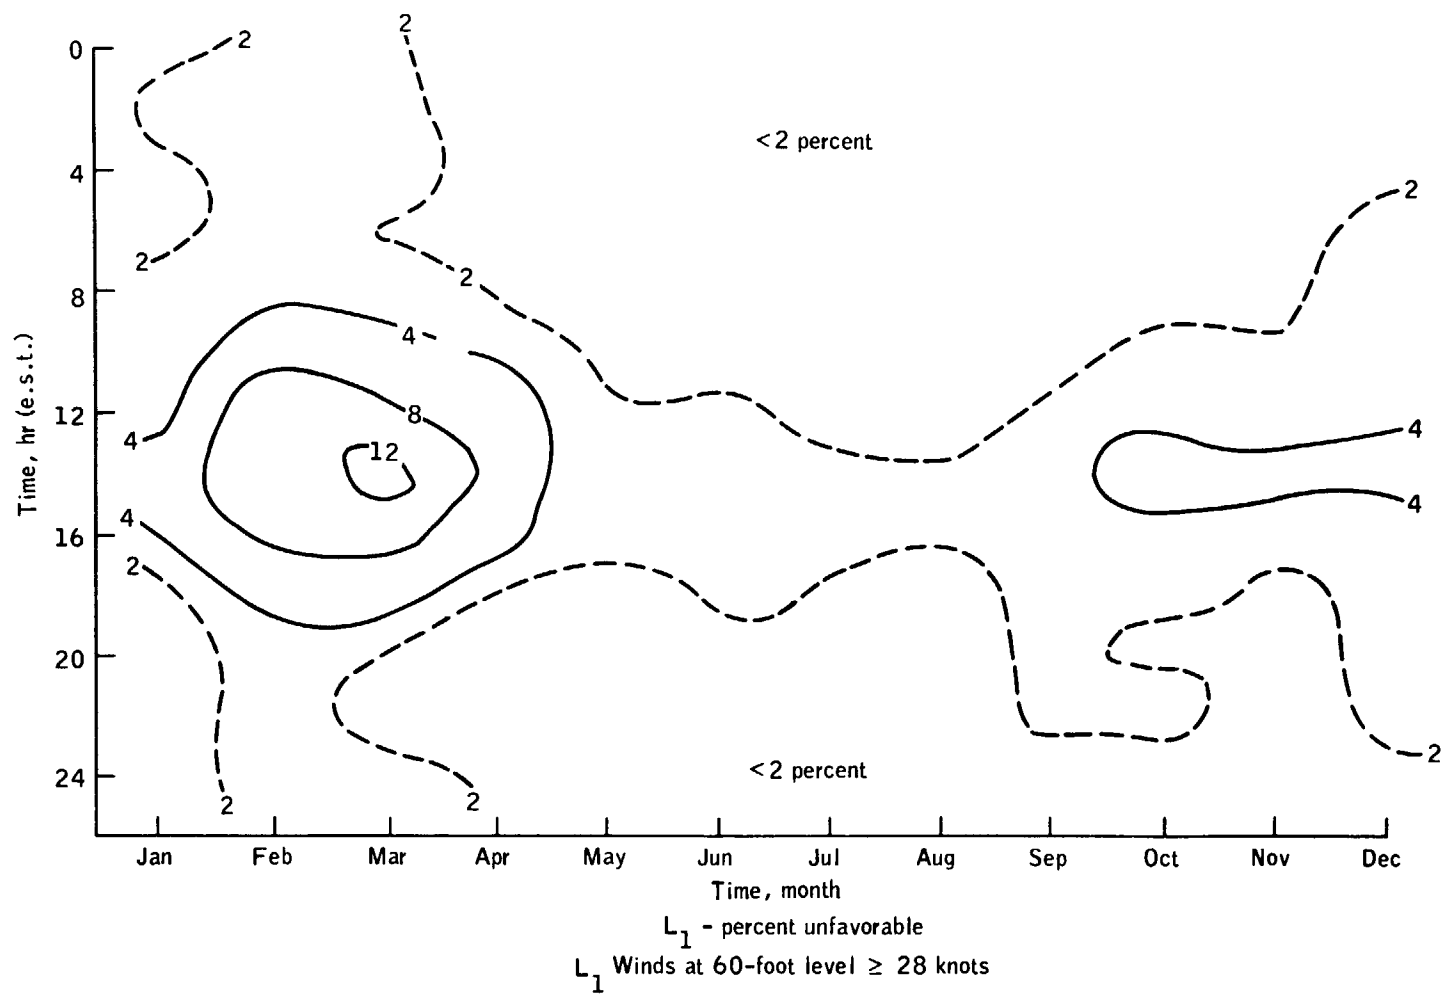
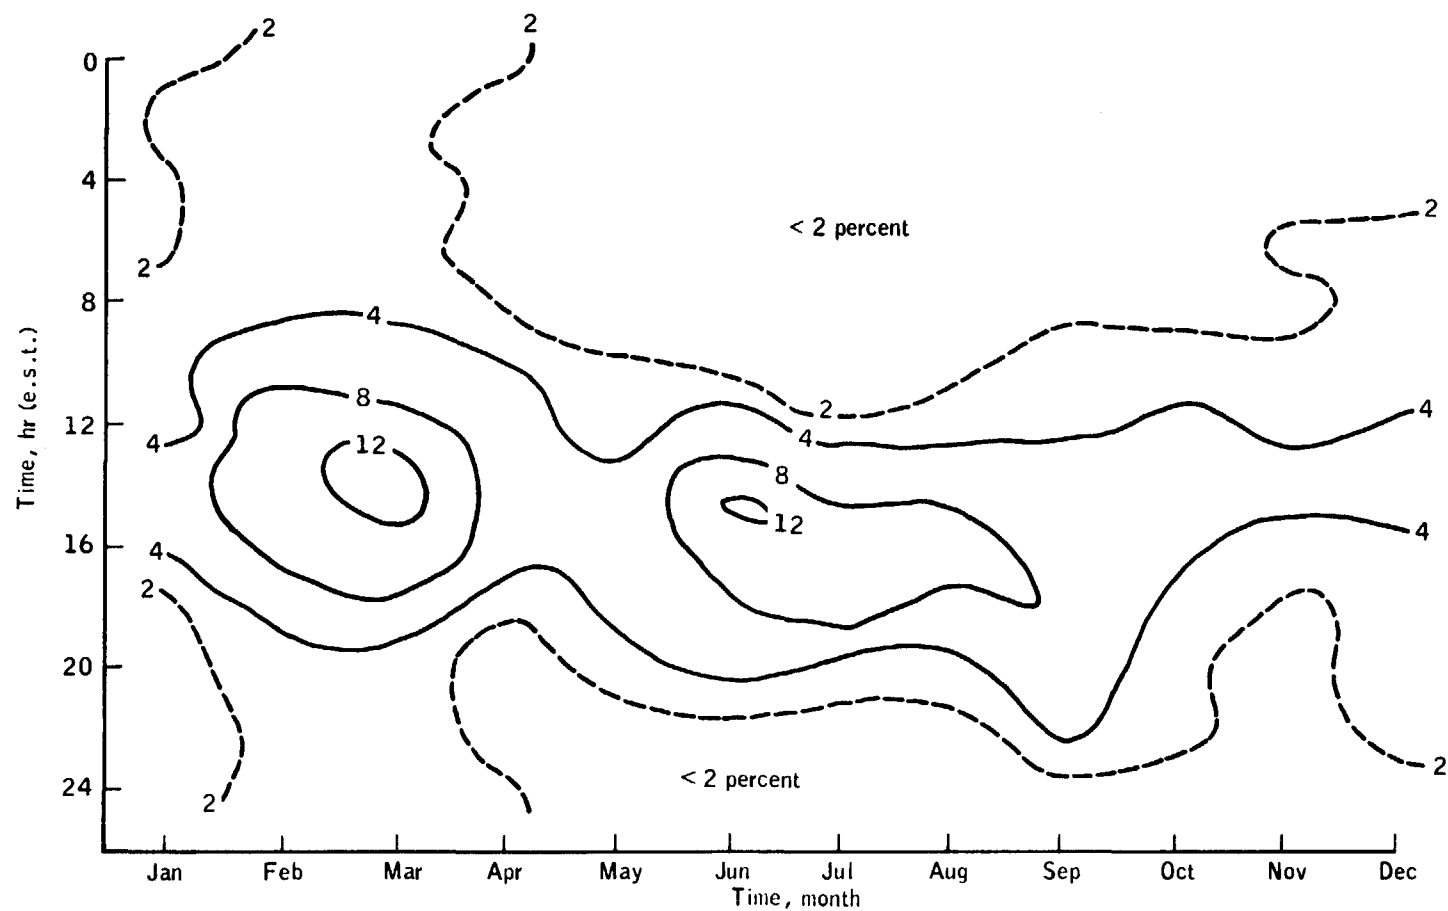
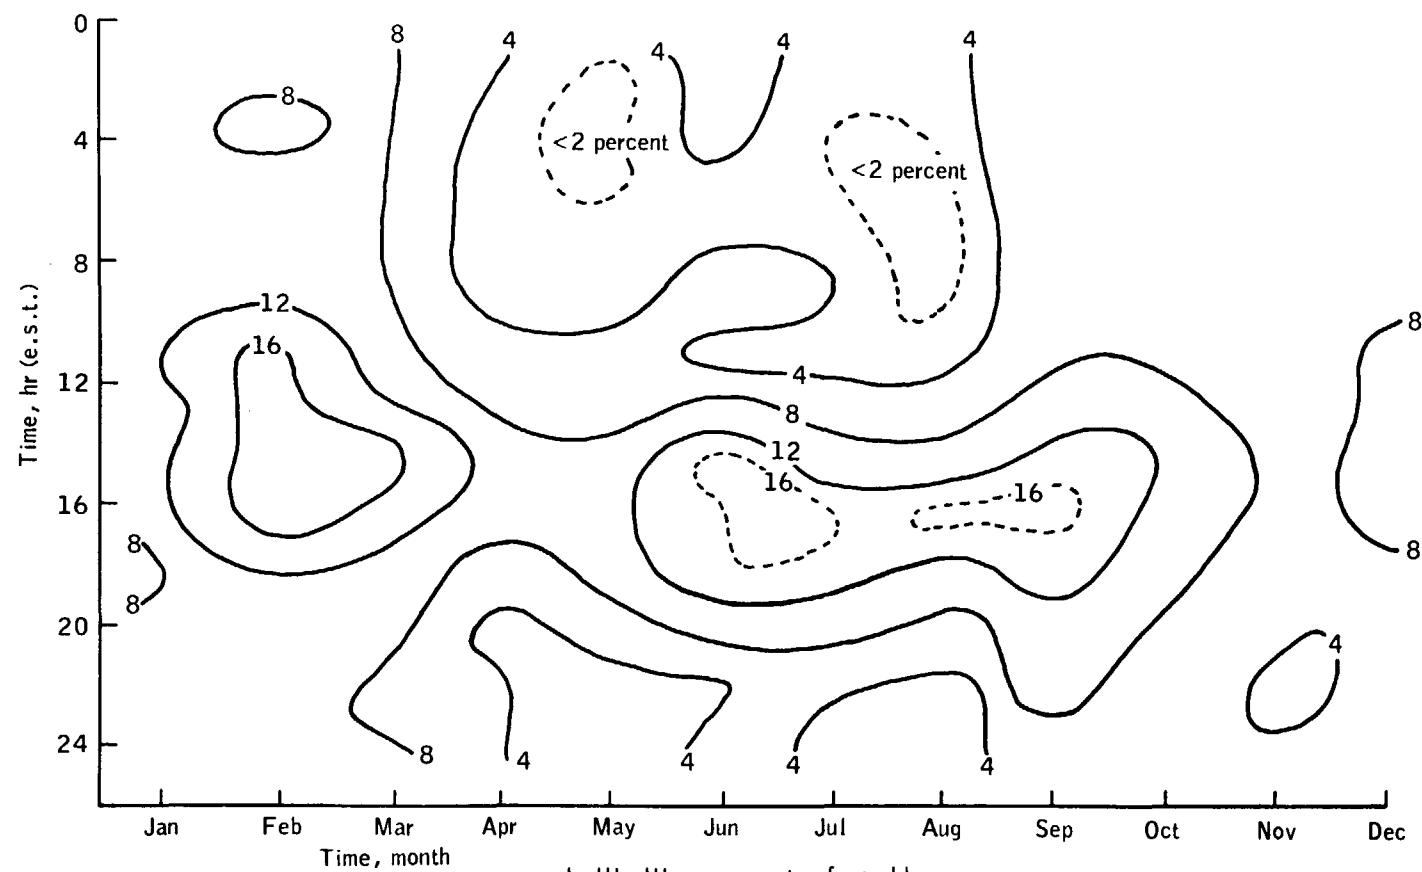
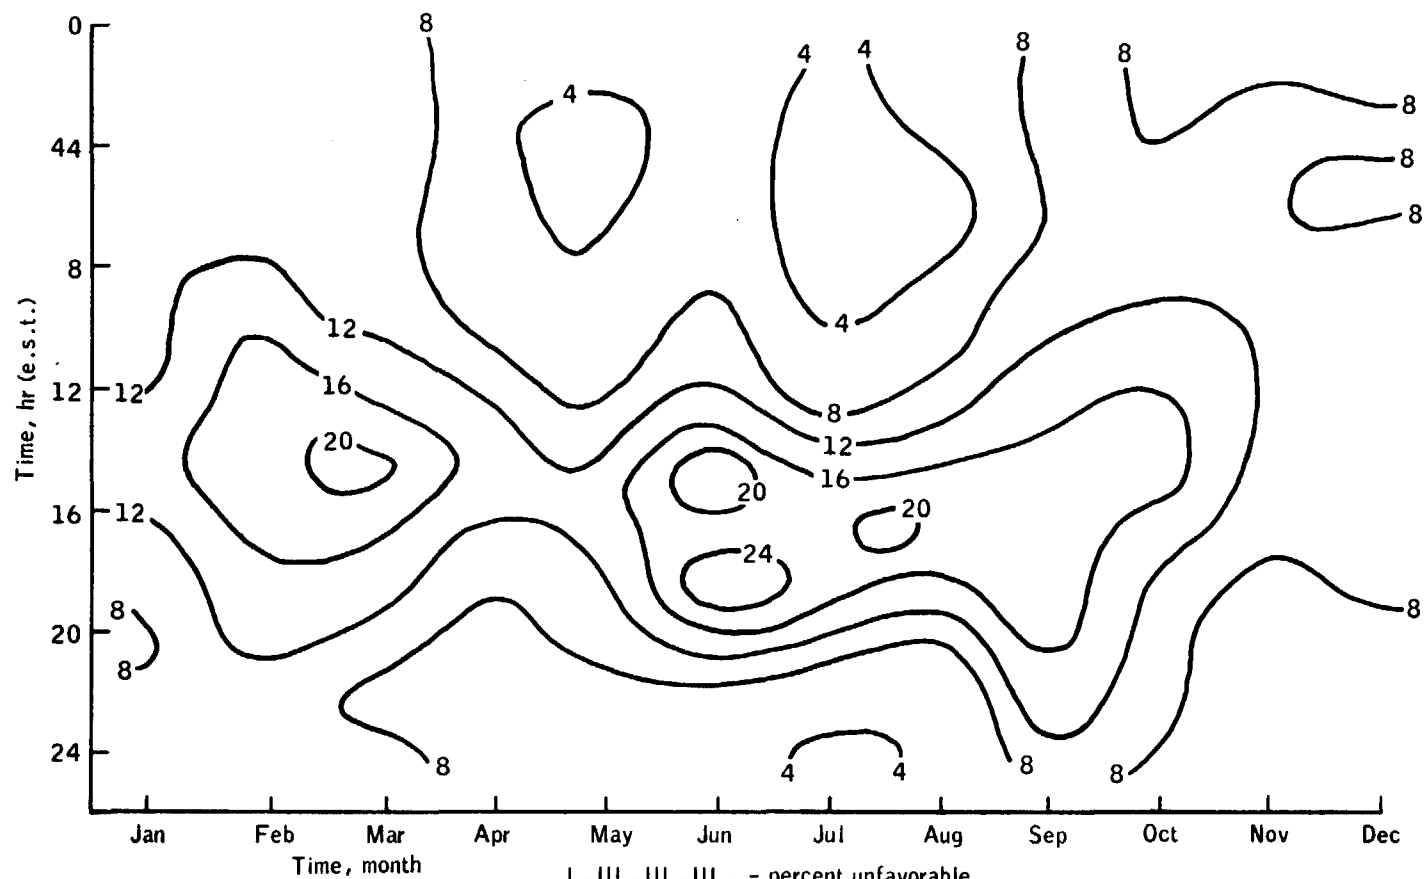
(a) Effect of winds only.

Figure 13.- Probability of weather conditions affecting launch.

(b) Winds and thunderstorms.

(c) Winds, thunderstorms, and all precipitation.

However, a constraint for no launch during rain (which is a strong indicator of high potential gradients in the clouds) adds two to four percent to the delay probability. This may not be critical depending upon launch window. When consideration is given to the launch window, the launch delay probabilities are reduced as the length of the launch window increases; for example, the delay probability becomes about one-half that shown in figure 13 for a 3-hour launch window.

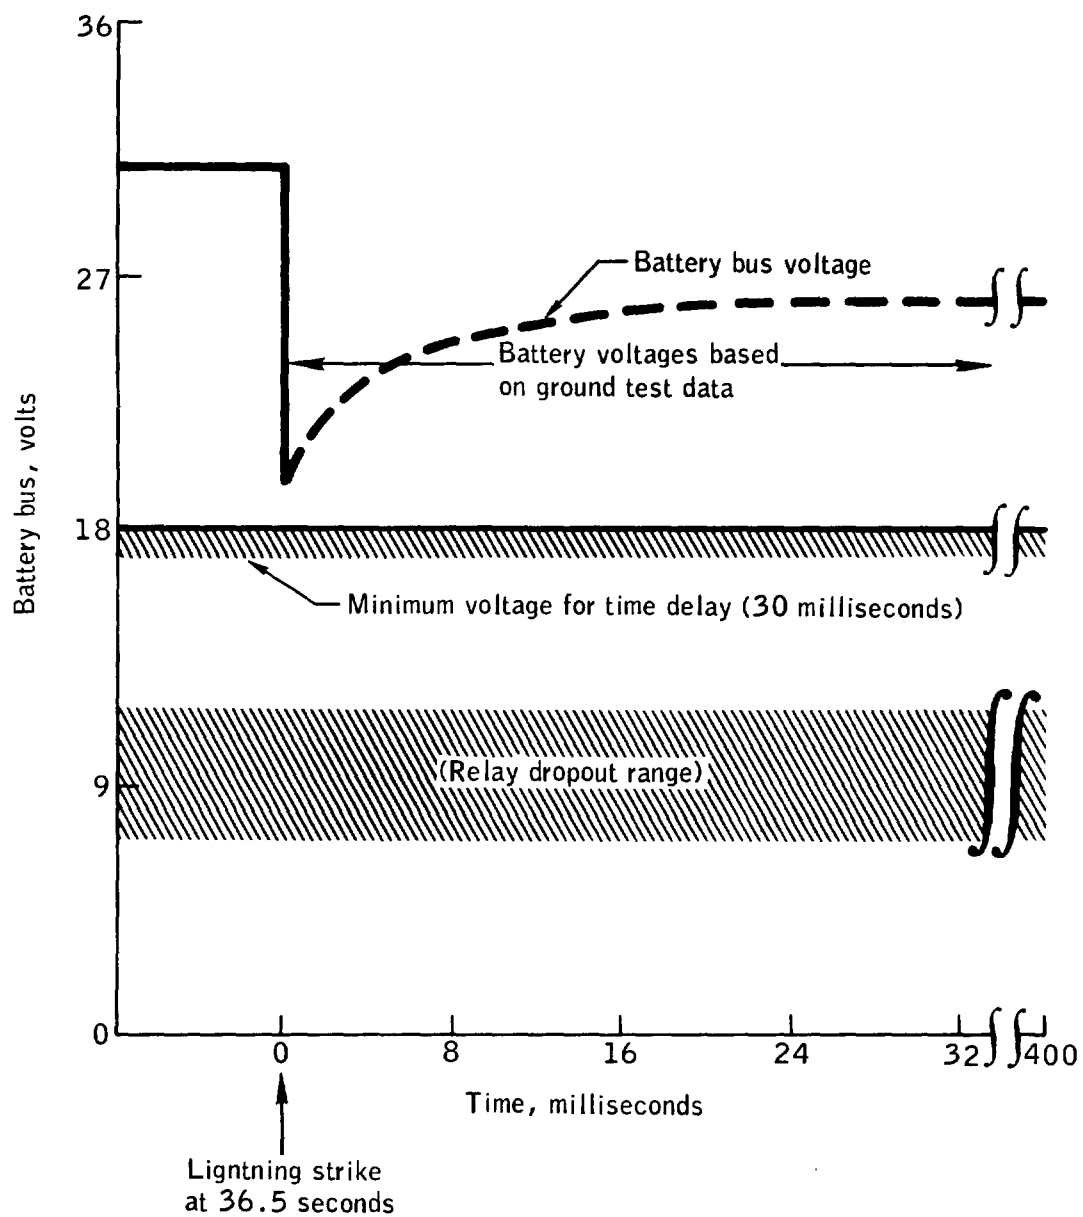
Figure 14.- Battery bus voltage and emergency detection system relay and timer voltage limits.

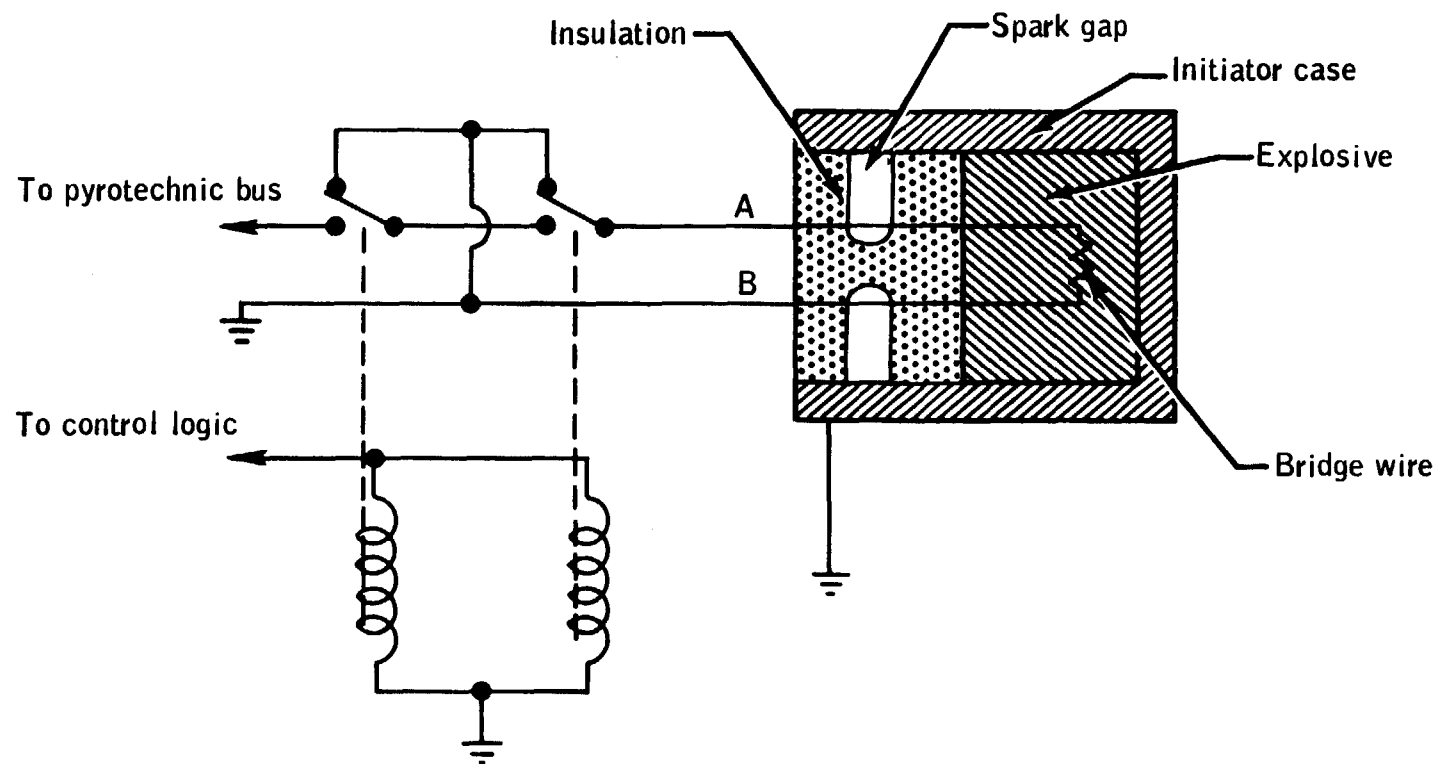
Figure 15.- Simplified schematic of the hot wire initiator.

In the first item, wires A and B are shorted by the normally closed contacts on the firing relay. If both wires are subjected to the same induced voltage, however large (ignoring any shielding), no current will flow through the bridge wire. In considering a differential induction on wire A and B, the canard deploy circuit was analyzed because of its close proximity to the skin over a long distance and the current density

The second item requires a potential between the initiator case and wire A or B. Again taking very conservative assumptions, a potential of 420 volts could exist from wire to case. Note in Figure 15 a spark gap is provided and is the lowest resistance path in the circuit. A potential of 1200 volts is necessary to cause a spark jump at this point. Each initiator is subjected to 25 000 volts to insure that the spark jump does not cause ignition.
