**ANALYSIS OF
APOLLO 12 LIGHTNING INCIDENT**

MARSHALL SPACE FLIGHT CENTER

KENNEDY SPACE CENTER

MANNED SPACECRAFT CENTER

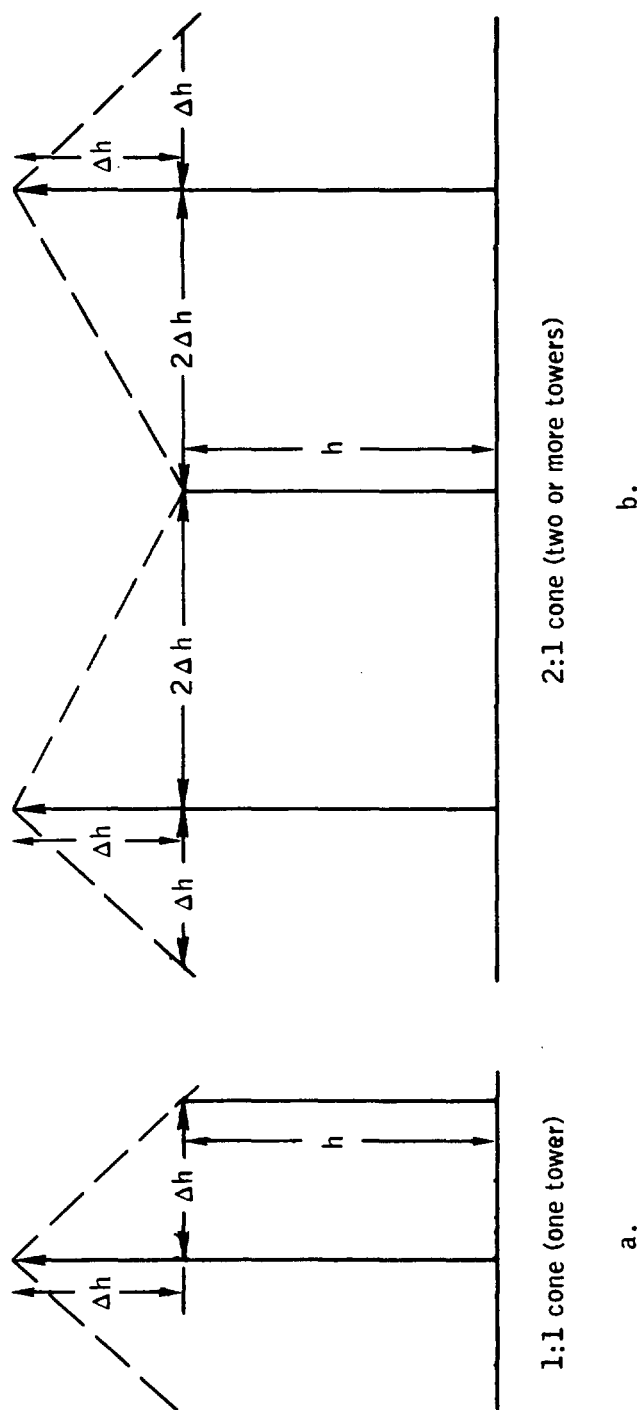
In the cone concept, the tallest structure represents the height of the apex of a cone having a finite base dimension. Structures within the volume of the cone will be protected by the tallest structure intercepting the lightning stroke. To be specific, a 1:1 cone of protection would include all other structures whose topmost points lay within a cone having a base radius equal to the height of the tallest structure. Adequacy in the 1:1 cone of protection is based upon historical data involving lightning strokes as well as laboratory testing. In laboratory tests, simulated lightning strokes could not be made to violate the 1:1 cone of protection. However, the 1:1 cone of protection does not prevent the flow of current on or through the vehicle should lightning strike the launch umbilical tower.

Figure 16.- Cone of protection criteria.

When a stroke hits the launch umbilical tower lightning mast, the stroke current will flow from the mast into the crane, through a sliding contact on the crane into the structural steel of the launch umbilical tower, and then into the ground grid through the supporting pedestals for the launch umbilical tower. There are no special conductors through the launch umbilical tower because the massive steel structure is capable of carrying the lightning currents. However, there are lightning conductors connecting the framework of the launch umbilical tower to the supporting pedestals and along the pedestals to the grounding system, although the pedestals themselves are sufficient for carrying the lightning currents to ground.

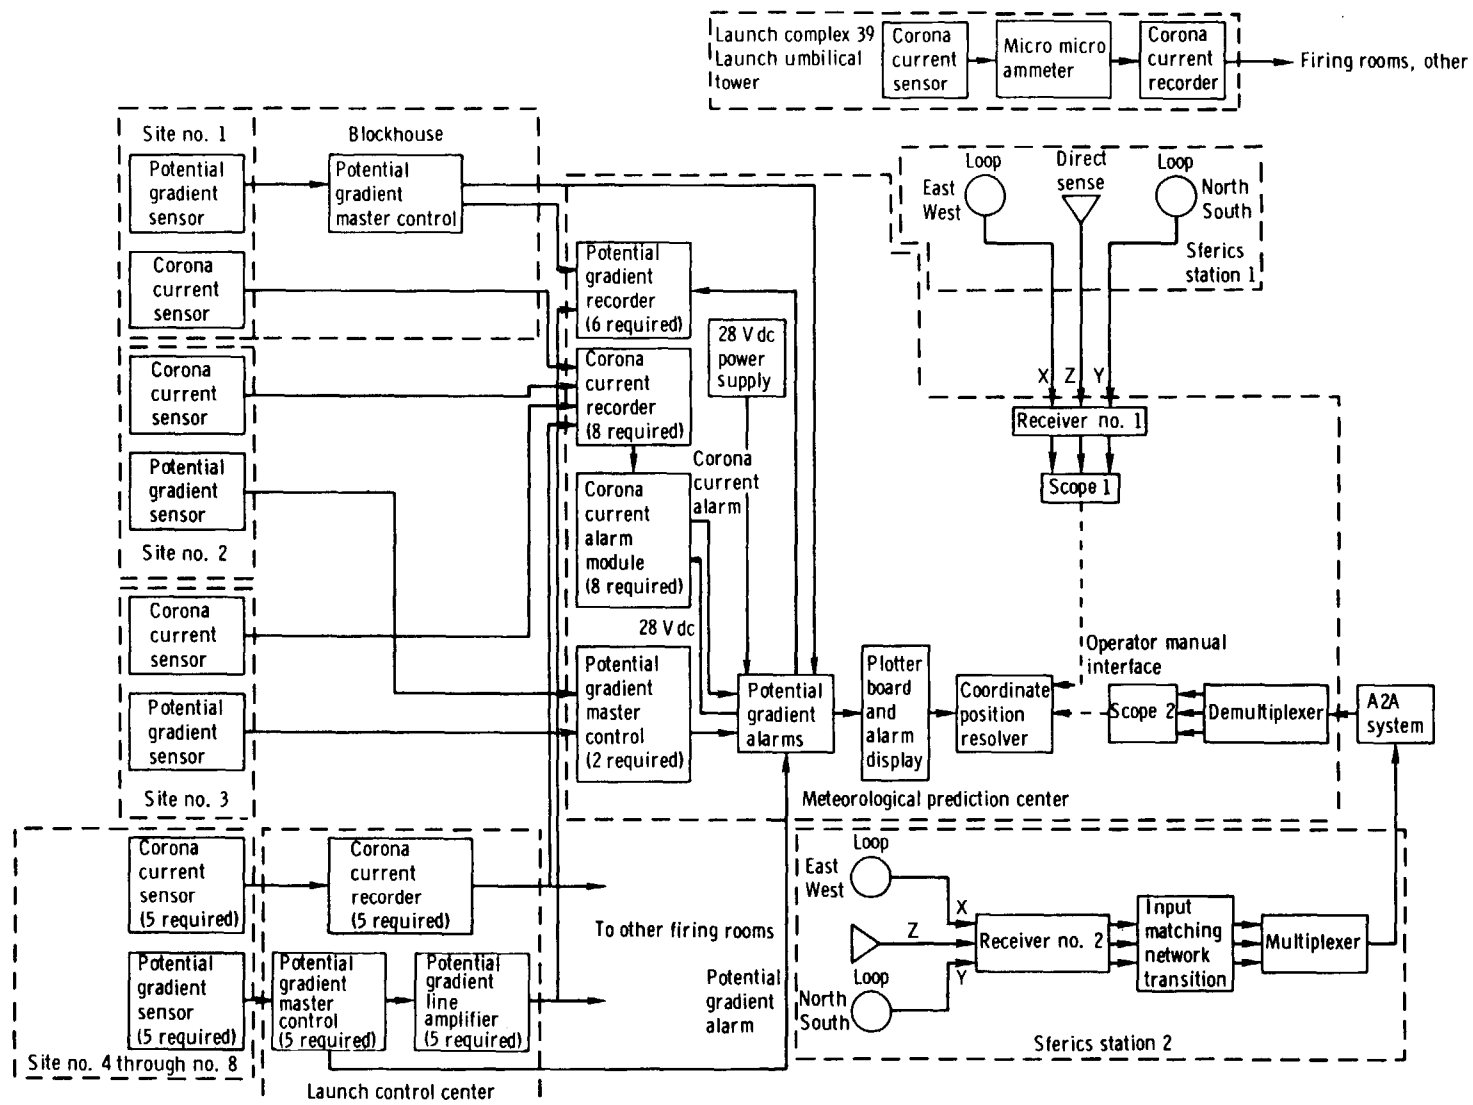
Figure A-1. - Composite schematic of lightning instrumentation system.

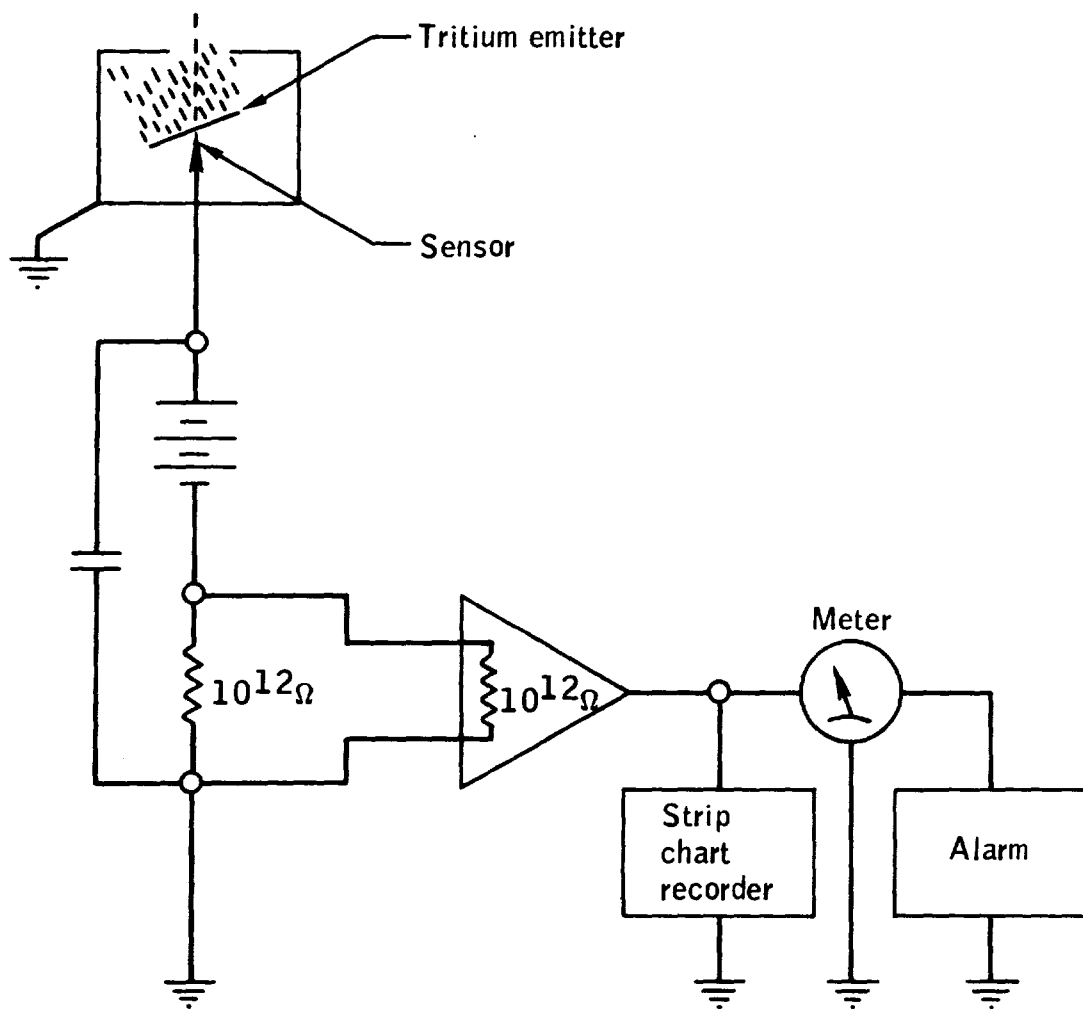
Figure A-2.- Potential gradient (radioactive device) functional schematic.

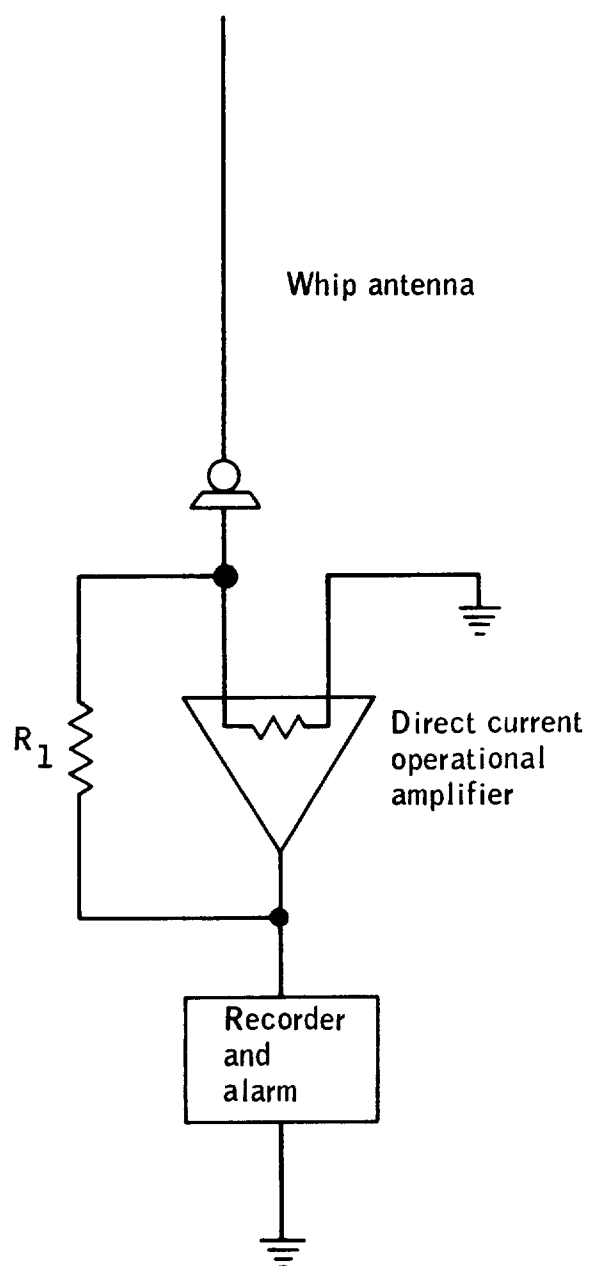
Figure A-3.- Corona current detection system functional schematic.

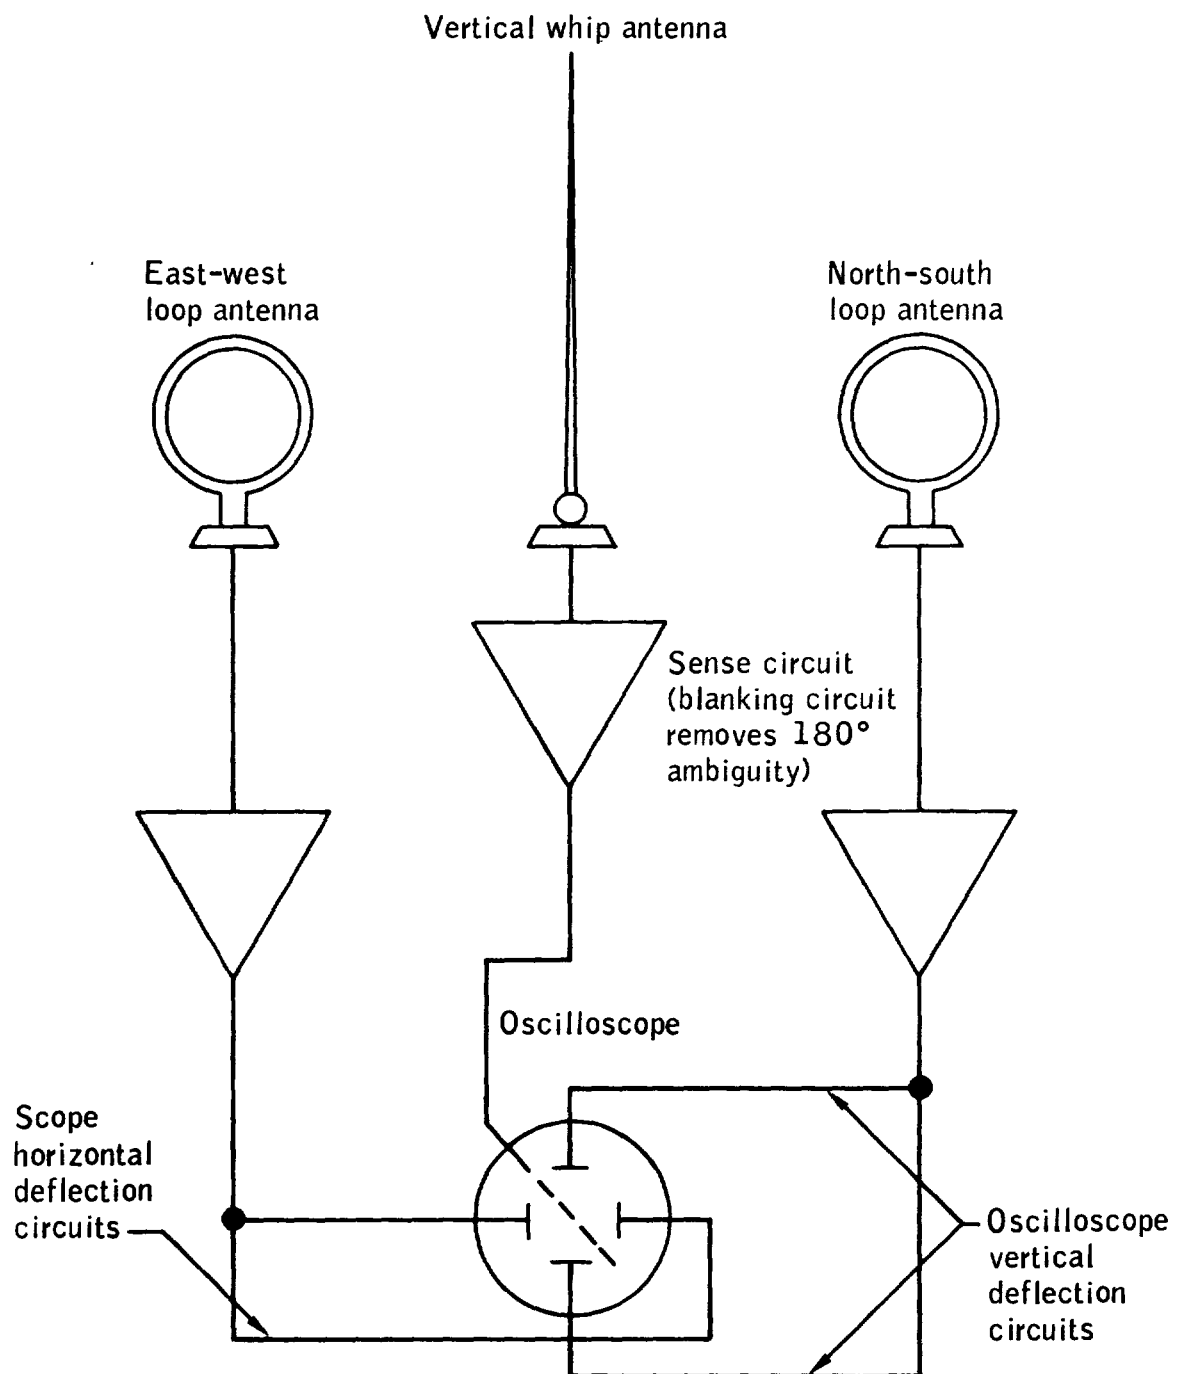
Figure A-4.- Sferic receiver functional schematic.

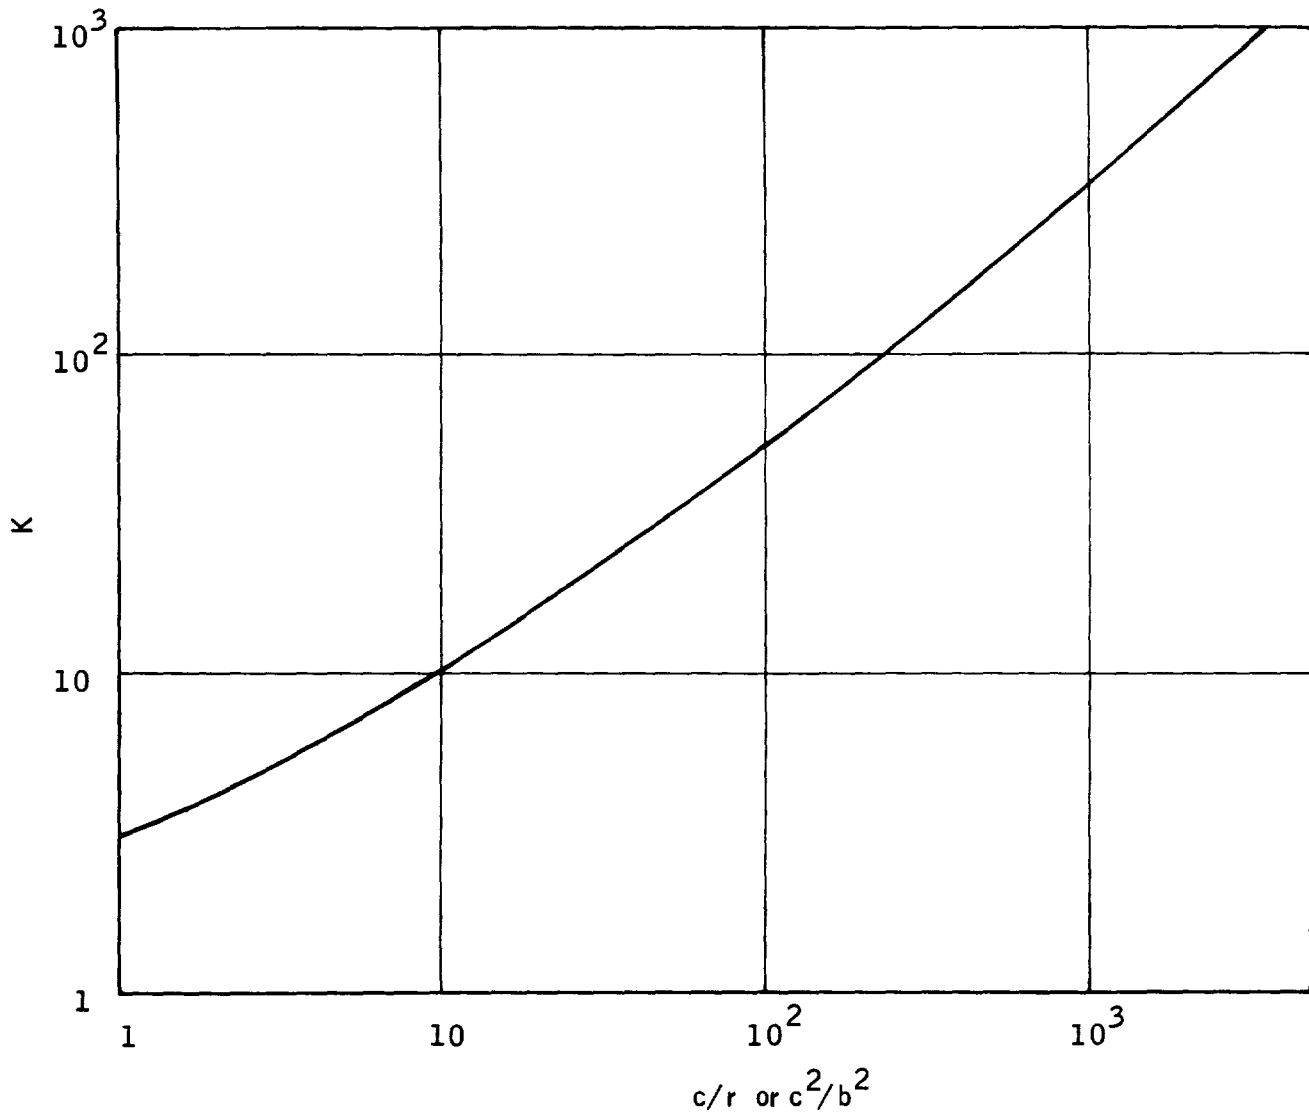
Figure 1. The electric field enhancement factor "K" at the top of a vertical, prolate ellipsoid versus the ratio of the height of the half ellipsoid c to the radius of curvature of the tip of r .

$$K = E_{\text{tip}}/E_{\text{undisturbed}} = \left\{ n(n^2 - 1) \left[\frac{1}{2} \ln \left(\frac{n+1}{n-1} \right) - \frac{1}{n} \right] \right\}^{-1}$$

For the benefit of the reader who may want to calculate enhancement factors for c/b ratios other than those given in Table 1, we have plotted in Figure 1 a curve of enhancement factor K vs the ratios $c/r = c^2/b^2$. Here r is the radius of curvature at the ends of the prolate spheroid.

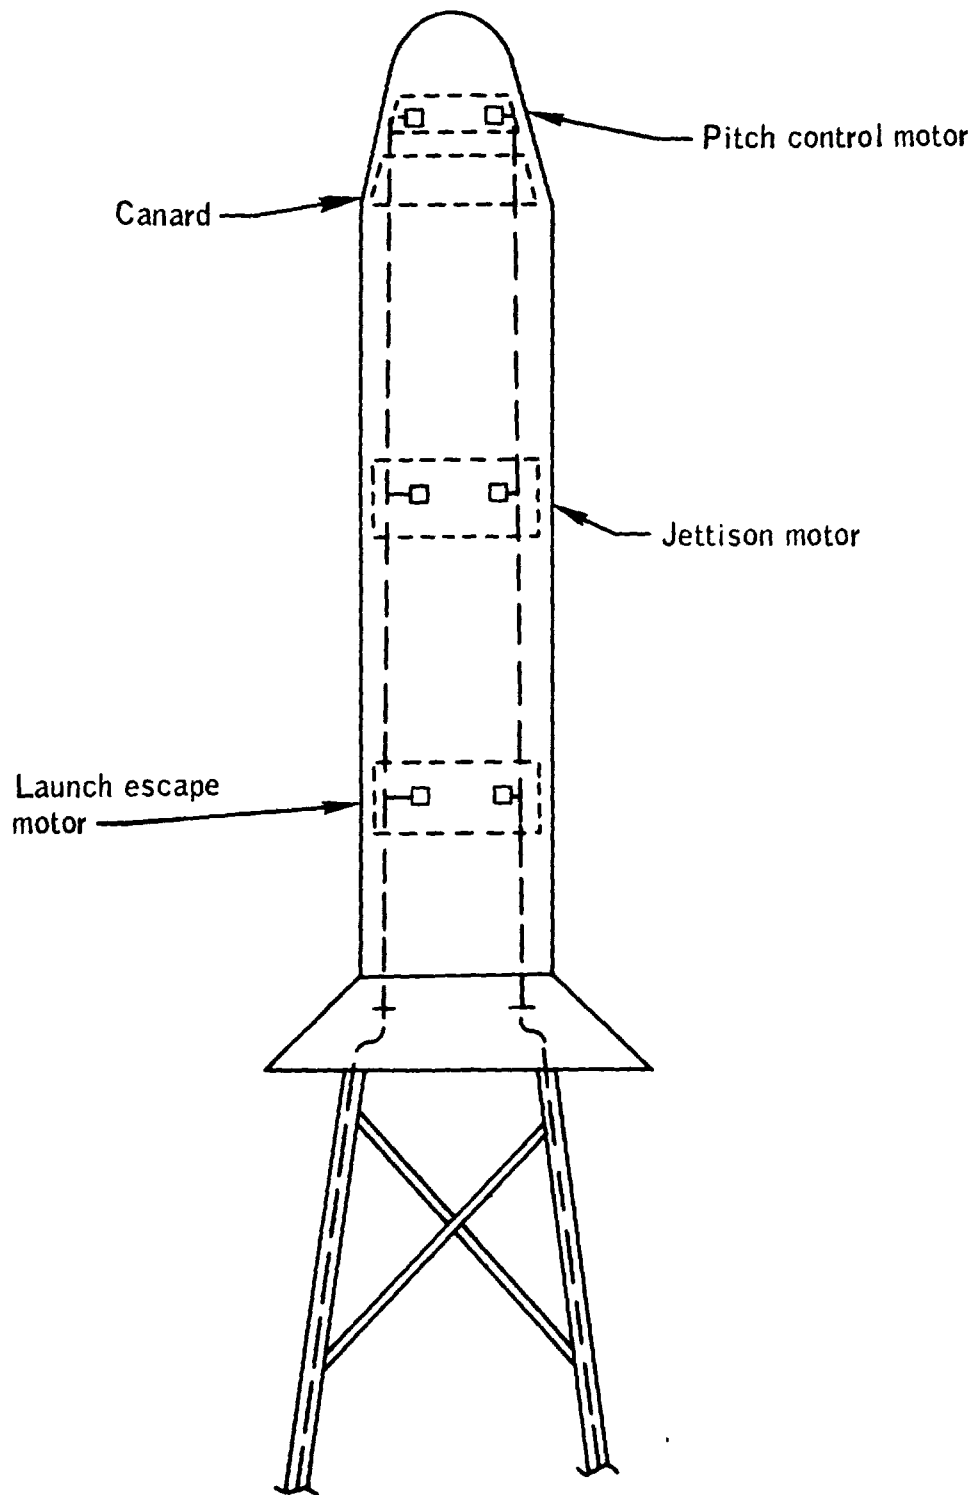
Figure C-2.- Tower pyrotechnic wire routing.
