Spray-on Layer to Protect Flame Trench

06.27.08

With its protective bricks torn away by the recent space shuttle launch, the flame trench at Launch Pad 39A will be given a new layer of protection in time for the next space shuttle liftoff.

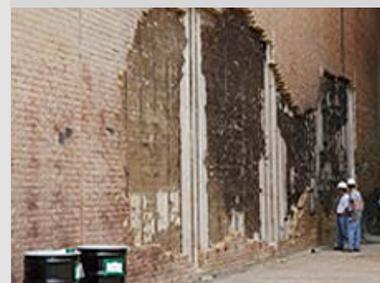
Workers look at the damaged wall of the flame trench at Launch Pad 39A. About 3,500 fire-resistant bricks dislodged from the wall during the STS-124 launch. Photo credit: NASA/Kim Shiflett

A swath of about 3,500 protective bricks tore away from the walls of the structure when space shuttle Discovery lifted off May 31 to begin its STS-124 mission. None of the bricks bounced back in the area of the shuttle. Preliminary computer models of the exhaust pattern suggest no likelihood of loose bricks coming back to the mobile launcher platform or the shuttle.

The bricks protect the reinforced concrete structure of the flame trench from 7 million pounds of thrust generated from the SRBs and temperatures of 2,600 degrees.

NASA's Perry Becker, who is leading the engineer investigation and repair effort, said it is too early to tell why the wall came apart during liftoff. The wall was built in 1965 and has endured 82 launches, including 12 liftoffs of the Saturn V rocket.

Each of the bricks weighs about 19 pounds each and the tongue & groove design allows them to interlock with each other for additional support. The force

of the shuttle's solid rocket boosters carried some of the bricks approximately 1,800 feet from the launch pad.

Engineers will remove brick from the wall with the damage and also may remove some sections of the opposite wall.
