**RESULTS OF THE SECOND
U.S. MANNED
SUBORBITAL SPACE FLIGHT
JULY 21, 1961**

**MANNED SPACECRAFT CENTER
NATIONAL AERONAUTICS
AND SPACE ADMINISTRATION**

FOREWORD

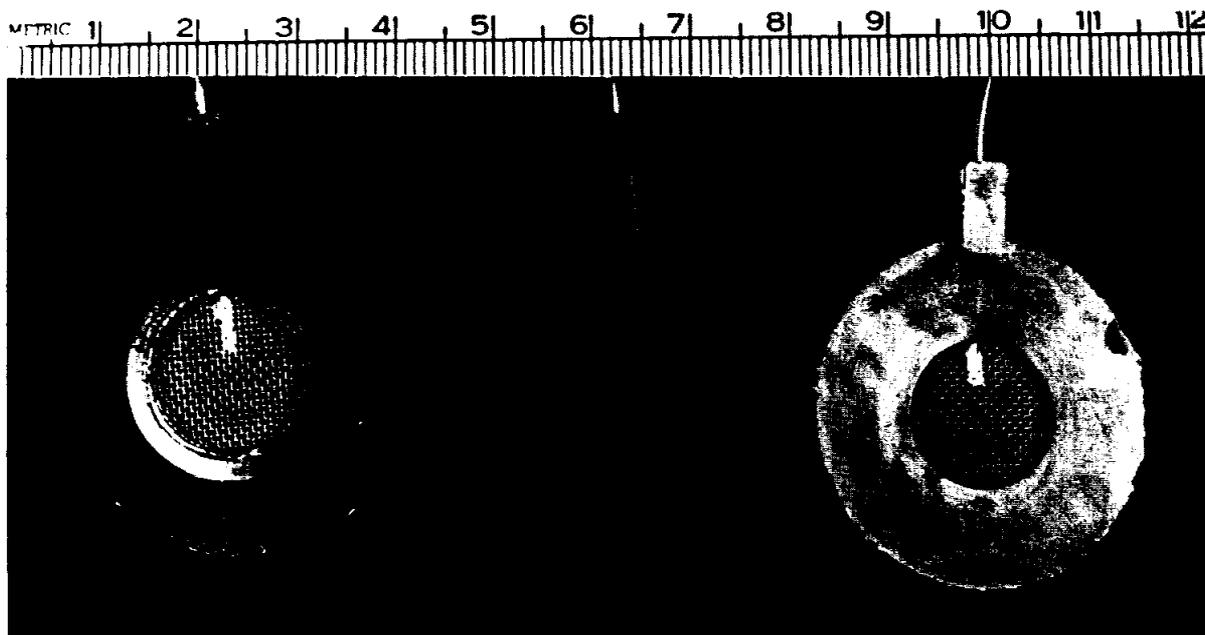
The next step in the preparatory procedures was the application of the biological sensor harness (figs. 5-1 and 5-2). This harness is described in detail in reference 2. The only difference between the sensors used in MR-3 and MR-4 flights was an alteration of the respiration sensor housing for the MR-4 flight to accommodate the microphone of different configuration used in the later flight. The surface of the electrode next to the skin is prepared with an adhesive material identical to that found on conventional adhesive tape (elastoplast).

FIGURE 5-1. Three views of a typical electrocardiograph floating electrode as used in Project Mercury. The surface of the electrode applied to the skin (right) is first painted with adhesive and then filled with bentonite paste.

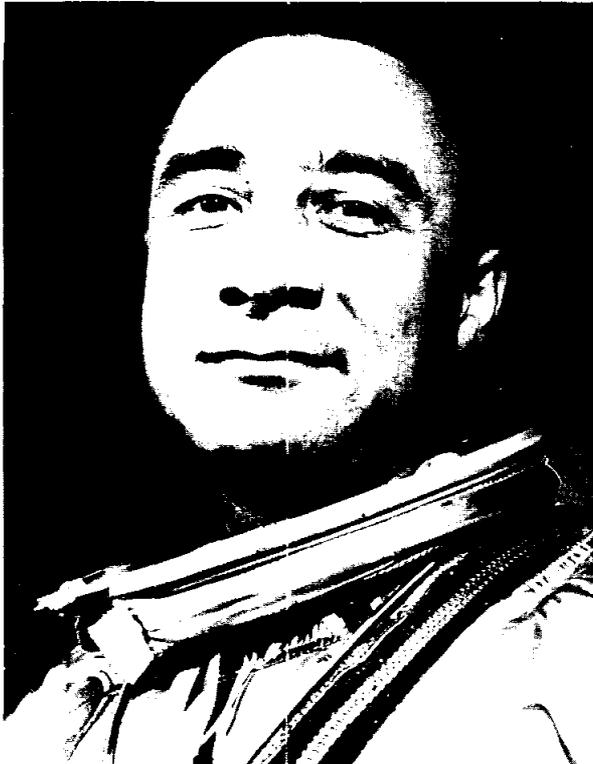
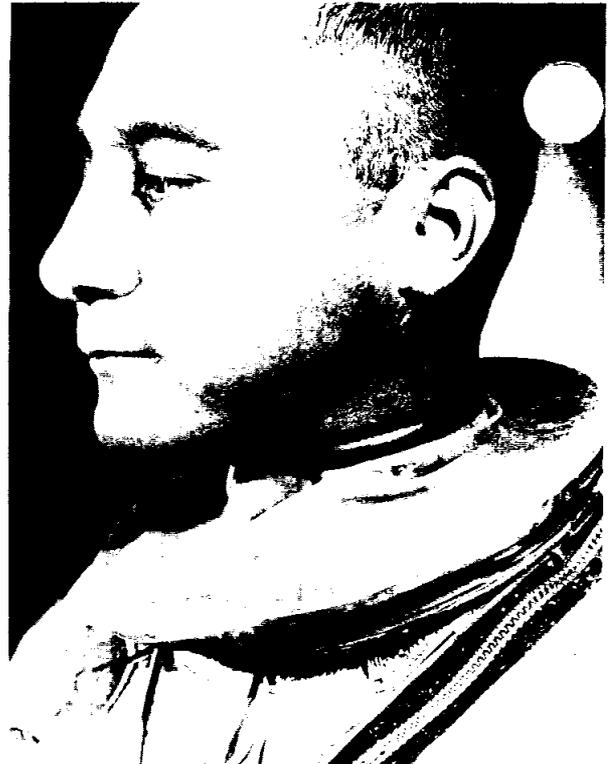
(a) Normal stored position.

(b) Unrolled position.

FIGURE 7-6. Neck dam.
