SYSTEM FAILURE CASE STUDIES

JUNE 2010 VOLUME 4 ISSUE 6

Tragic Tangle

Soyuz-1 crashes due to parachute malfunction, crewman killed.

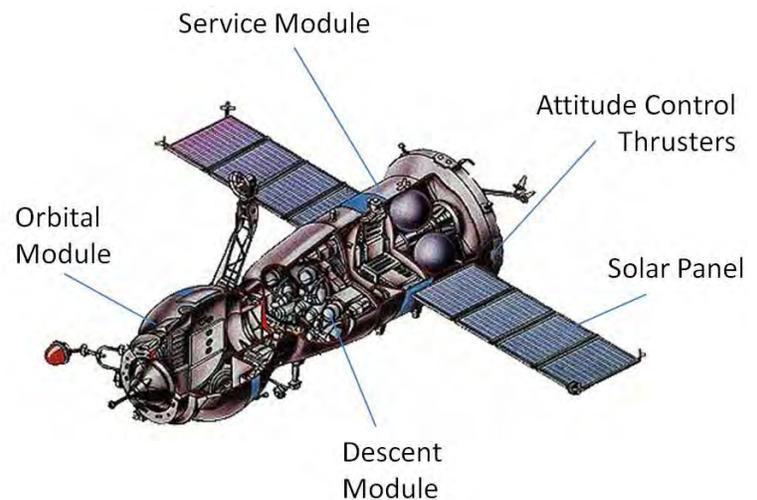
Figure 2: Diagram of a Soyuz space vehicle

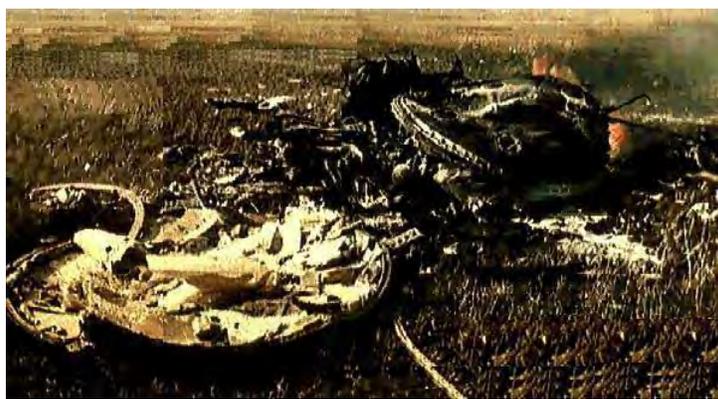
As *Soyuz-1* began to enter the atmosphere, it may have tumbled due to the stuck solar panel. The drag parachute deployed to slow the spacecraft enough for the main parachute to open without shredding; however, the main parachute was jammed inside its container. Sensors detected *Soyuz-1*'s increased velocity and activated the backup system. The backup system was programmed to eject both the drag and main parachutes before deploying the backup parachute; however, since the main parachute was stuck in its container, the primary apparatus remained attached to the spaceship. The drag chute remained flapping above the craft, and when the system deployed the backup parachute, the drag chute prevented it from unfurling. Without any means to reduce its tremendous speed, *Soyuz-1* slammed to the Earth at 90 miles per hour. Impact velocity would have been fatal. Fire consumed the spacecraft (Figure 3).

Although *Soyuz-1* encountered several in-flight malfunctions, none of them were a direct cause of this tragedy. *Soyuz-1*'s destruction resulted from a failure in the primary parachute's deployment, which subsequently caused the backup system to malfunction. The tangled parachutes never opened, hurtling *Soyuz-1* towards Earth and killing Vladimir Komarov upon impact (Figure 3).

Figure 3: The charred remains of Soyuz-1

After the accident, an investigation team comprised of engineers, top officials, and program leaders determined the main parachute failed to deploy because of the pressure difference between the interior of the parachute container and the atmosphere.

It was later found that TsKBEM's manufacturing technicians had committed a grave mistake while *Soyuz-1* and *Soyuz-2* were under construction. To prepare the ships for flight, technicians coated them with a thermal protectant. The ships were then baked in a high-temperature test chamber to polymerize the coating, but the parachute containers did not have their covers during this process. Consequently, masses of hard resin built up inside the containers and impeded the chutes' ability to deploy.
