System Failure Case Studies

DECEMBER 2007

Volume 1 Issue 10

POWERLESS

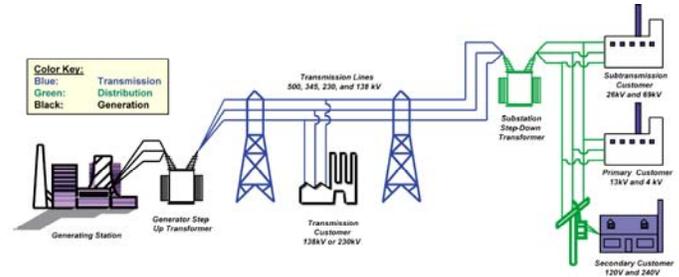
Basic Structure of the Electric System.

The electrical power system or grid produces electricity from fuel sources, such as nuclear, coal, oil, natural gas, hydro power, geothermal, etc. Low voltage electricity from the generators (10,000 - 25,000 volts) is "stepped up" to higher voltages (230,000 - 765,000 volts) for transmission over power lines. Transmission lines are interconnected at switching stations and substations to form a network. Electricity flows through the network following the laws of physics—along "paths of least resistance," the same way that water flows through a network of canals. When the power arrives near a load center, it is stepped down to lower voltages for distribution to residential customers (120 and 240 volts) or larger industrial and commercial customers (12,000 - 115,000 volts).

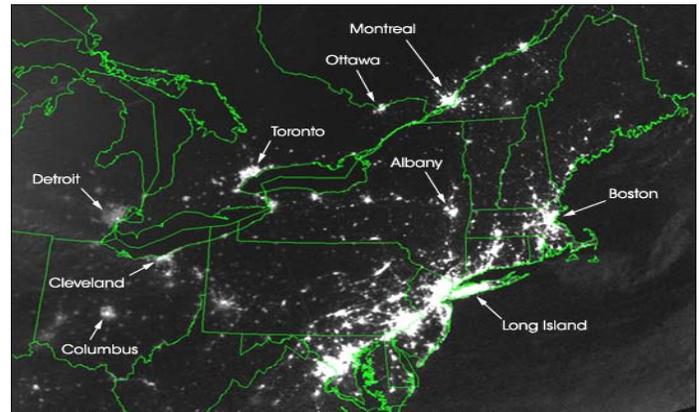
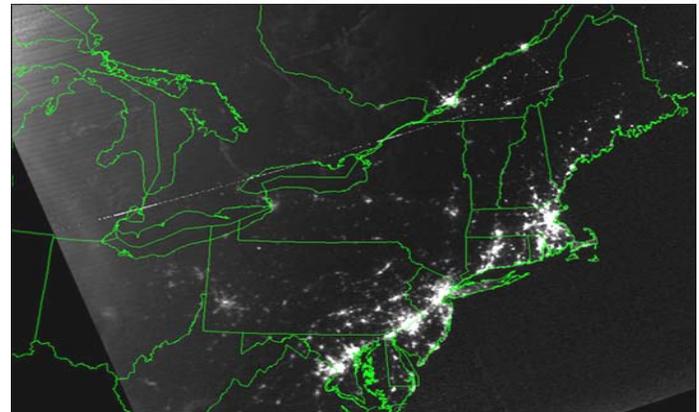
August 14, 2003 • 9:29 p.m. EDT • About 20 hours before blackout

August 15, 2003 • 9:14 p.m. EDT • About 7 hours after blackout

*Satellite Photos of Northeastern U.S. and Canada
Before and After the Blackout.*

The loss of the Sammis-Star line instantly created major and unsustainable burdens on other transmission lines throughout northeastern Ohio and triggered cascading failures throughout Northeastern U.S. and Canada. The cascade started at 4:06 p.m. and spread in less than seven minutes throughout an area of roughly 9,300 square miles, bounded by Lansing, Michigan, Sault Ste. Marie, the shore of James Bay, Ottawa, metropolitan New York and Toledo. Automatic protective relays in lines and power generating units located in Cleveland, Toledo, New York City, Buffalo, Albany, Detroit, and New Jersey were tripped. More than 508 generating units at 265 power plants, including 22 nuclear power plants, shut

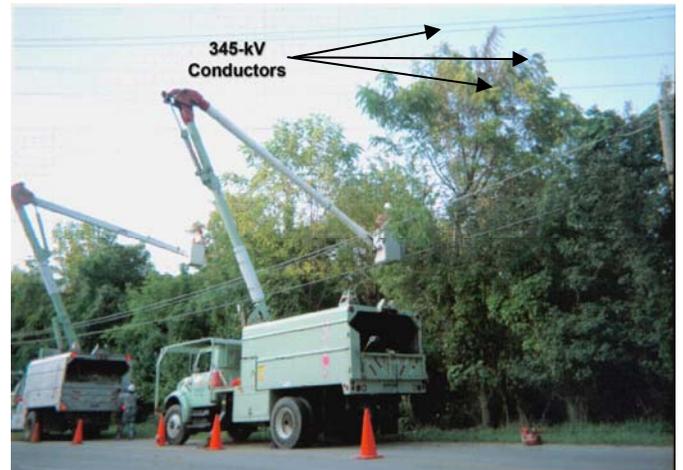
FirstEnergy failed to follow its own tree trimming policies (also known as vegetation management), which resulted in the failure of the three 345-kV transmission lines and one 138-kV line in its Ohio service area.

345-kV Lines Contacting Overgrown Trees in Ohio.

Furthermore, FirstEnergy rewrote its operator procedures and training programs to reflect the new systems, created a certification program to ensure operators fully understand their networks and systems as well as improve their reactions to emergency situations. It established new communication protocols for computer system repair and maintenance downtimes between their operations and IT staffs. An emergency response plan was created that focused on controlled load reductions of up to 1,500 megawatts for the Cleveland-Akron area. Tree trimming procedures and compliance were tightened.
